# BANK STREET ARMORY

## PRELIMINARY EXISTING CONDITIONS REPORT

72 Bank Street  
Fall River, MA

Prepared by the Preservation Society of Fall River, Inc.

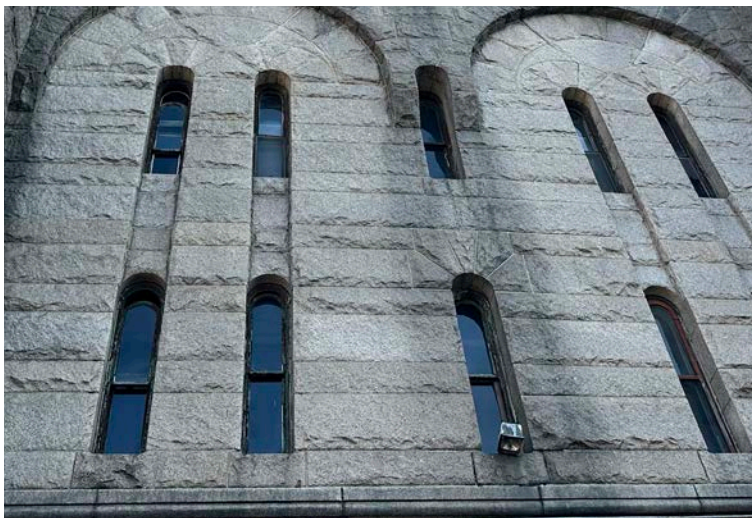
Figure 2 - Exterior Front (South Facing)

The front façade of the Bank Street Armory appears to remain in generally fair and stable condition, particularly when compared to conditions documented in the 2015 study. The building’s Romanesque Revival masonry construction appears largely intact, with no immediately visible signs of significant structural displacement or widespread material failure. Consistent with prior observations, there remain several damaged or missing windows, which have been temporarily secured with boarding. Encroaching vegetation in close proximity to the south side of the building façade, may also contribute to moisture retention.

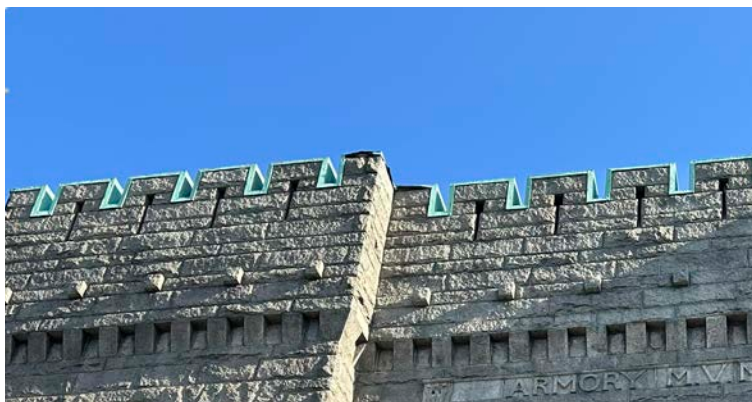
Figure 3 - Exterior Front (South Facing)

The stone façade shows localized weathering and minor surface deterioration, consistent with age and long-term exposure, though the overall integrity of the masonry units and mortar joints appears to be holding. The crenellations and upper wall sections do not exhibit obvious deformation or loss.

It was observed that a section of the copper flashing along the roof line of the primary façade has become detached and displaced, specifically along the crenellated parapet. The flashing appears lifted and uneven in one section, exposing underlying joints and creating a potential point of water infiltration. Given the building’s rusticated stone construction and pronounced horizontal ledges, this condition may allow moisture to penetrate behind the masonry, accelerating deterioration of mortar joints and contributing to freeze-thaw damage. The remainder of the southern roof edge appears generally intact from this vantage point.

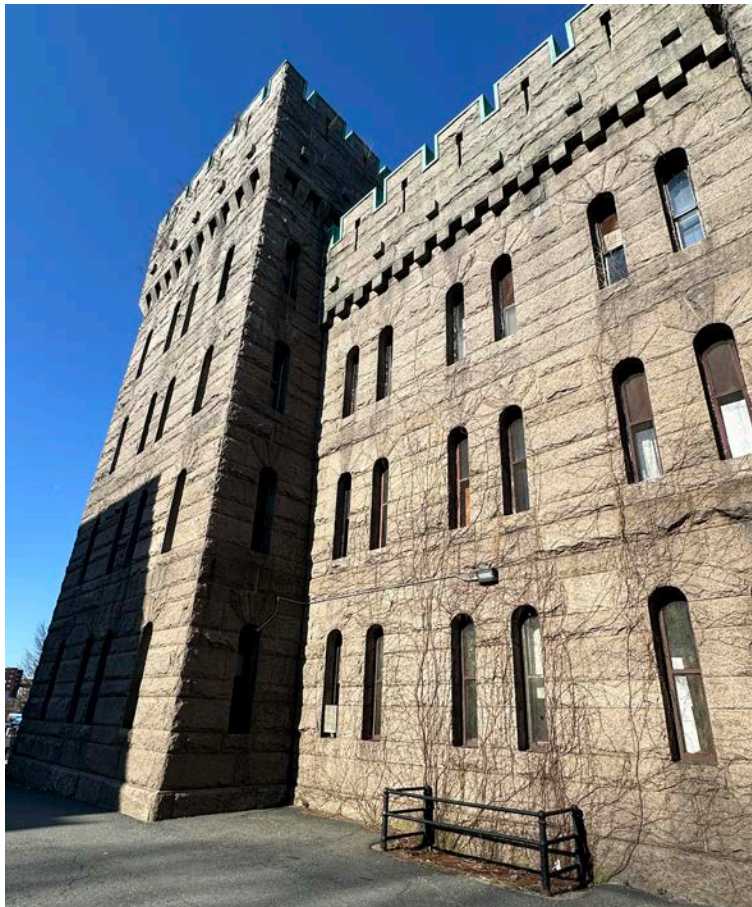
Figure 4 - Exterior Side (East Facing)

The east façade of the Armory exhibits notable biological growth, with climbing vegetation extending from grade level up the masonry wall to the second story and additional plant growth emerging from the parapet. This vegetation poses a risk to the long-term integrity of the masonry, as root systems and retained moisture can contribute to joint deterioration, displacement of stone units, and accelerated weathering. Despite these concerns, the stone masonry itself appears to be in generally good and stable condition overall, with no immediately apparent large-scale structural distress.

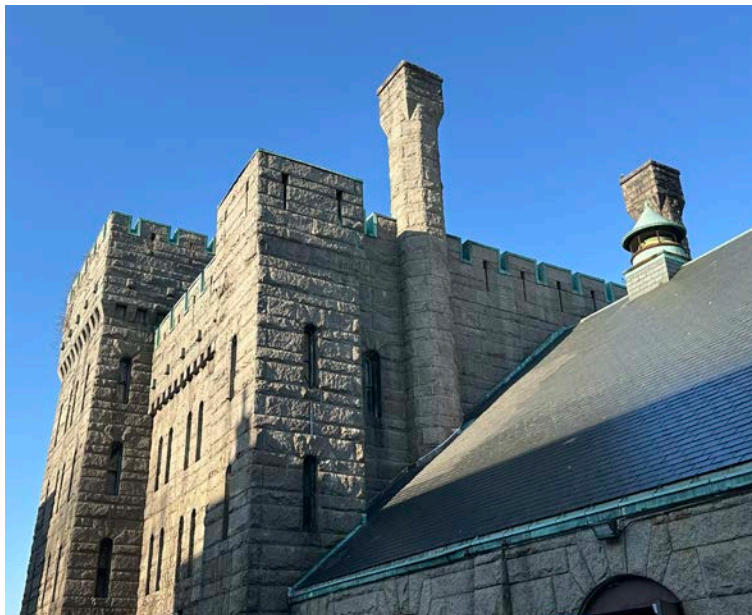
Figure 5 - Exterior Side (East Facing)

The granite chimneys, which were previously repaired and reconstructed under Community Preservation Act grants in FY17 and FY18, appear to remain in good condition based on visual observation from grade. The masonry units are generally uniform in color and alignment, with no readily apparent displacement, cracking, or loss of material. Mortar joints appear intact and consistent, suggesting that the prior repointing work is performing as intended. The chimney caps and upper courses also appear stable, with no visible signs of deterioration or water infiltration from this vantage point. While the overall condition is favorable, it should be noted that this assessment is limited to ground-level observation; closer inspection would be required to fully evaluate joint integrity, flashing conditions, and any weathering at upper elevations not visible from below.

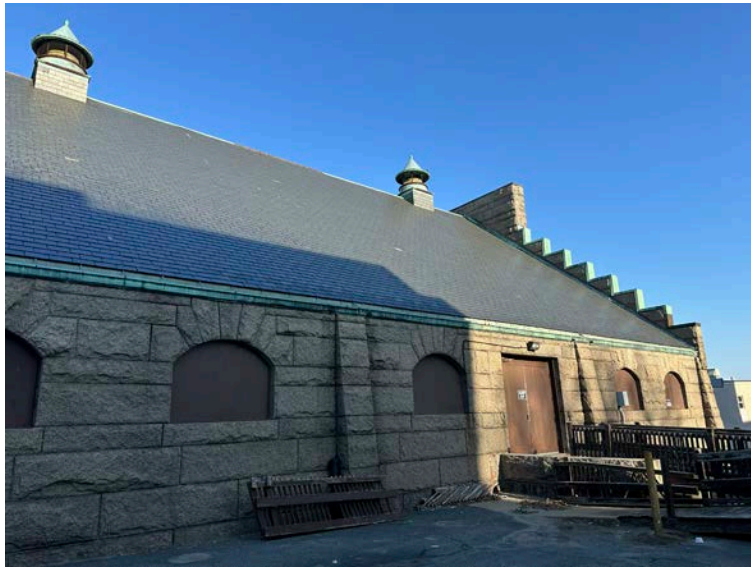
Figure 6 - Exterior Side (East Facing)

Overall, the Drill Hall appears to be in generally good condition. The slate roof, which was recently replaced, is intact and performing well, with no visible areas of significant displacement or failure. The granite masonry walls appear stable and well-maintained overall, with mortar joints generally in good condition. However, localized areas of deterioration are visible, particularly at window openings where joints interface with boarded infill panels. These areas exhibit minor gaps and potential joint erosion, which may allow for moisture infiltration if left unaddressed. All window openings along this elevation are currently boarded, suggesting either prior damage or ongoing efforts to secure the building envelope. The boarded conditions obscure the full extent of window deterioration but indicate that the original window systems are likely compromised or missing.

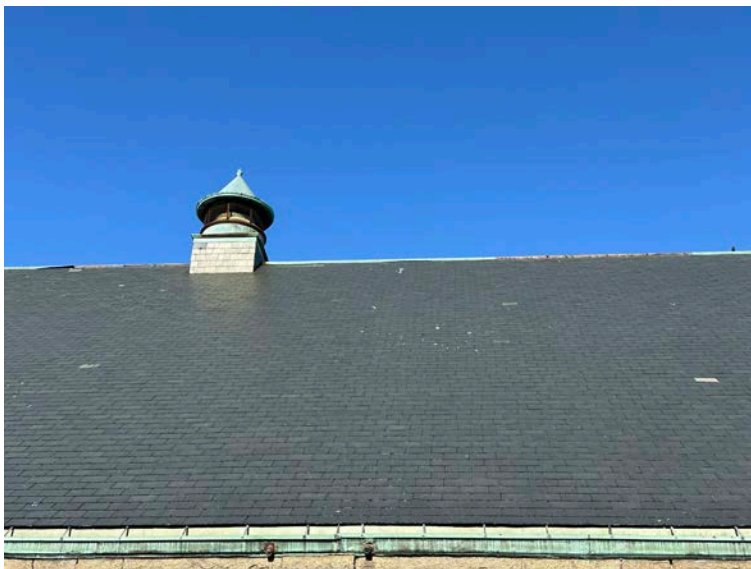
Figure 7 - Exterior Side (East Facing)

The copper flashing and trim elements along the eaves and parapet edges appear largely continuous. Slate shingles not missing.

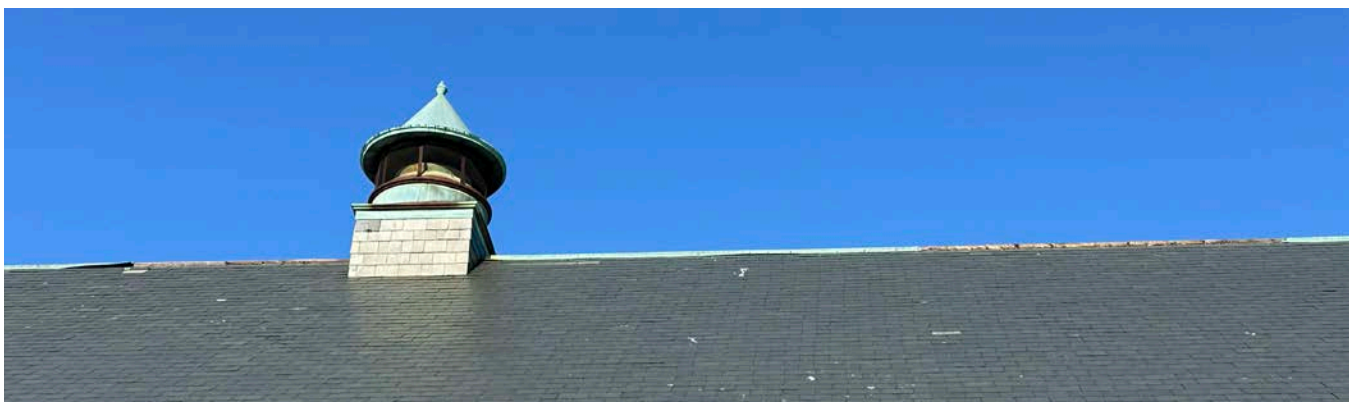
Figure 8 - Exterior Side (East Facing)

Two notable sections of the copper flashing along the roof line appear to be missing along the center.

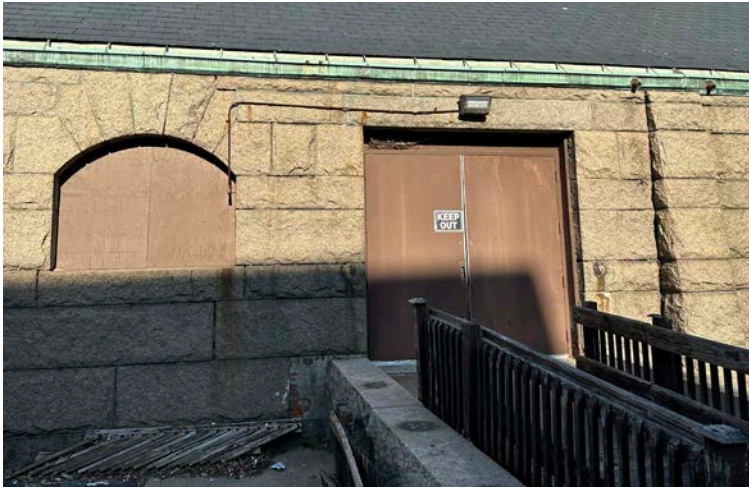
Figure 9 - Exterior Side (East Facing)

Site elements adjacent to the building, including stored materials and deteriorated wood components near the entrance at the ground level.

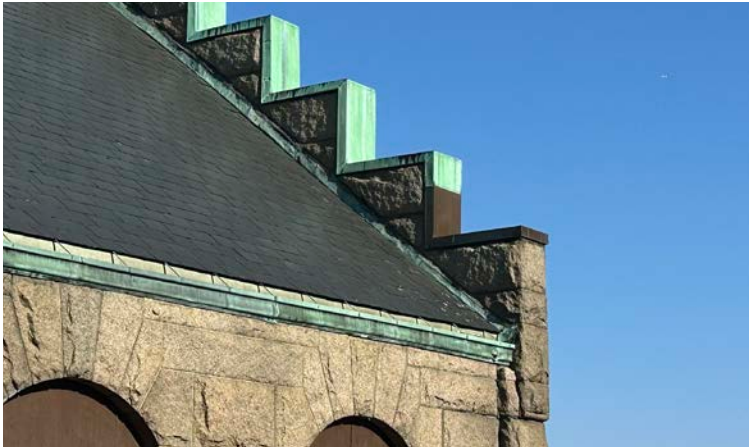
Figure 10 - Exterior Side (East Facing)

At the right side of the elevation, the stepped parapet and associated copper coping appear intact, though weathering is evident. Inconsistent coloring of the flashing is likely the result of some material replacement with aluminum flashing instead of copper.

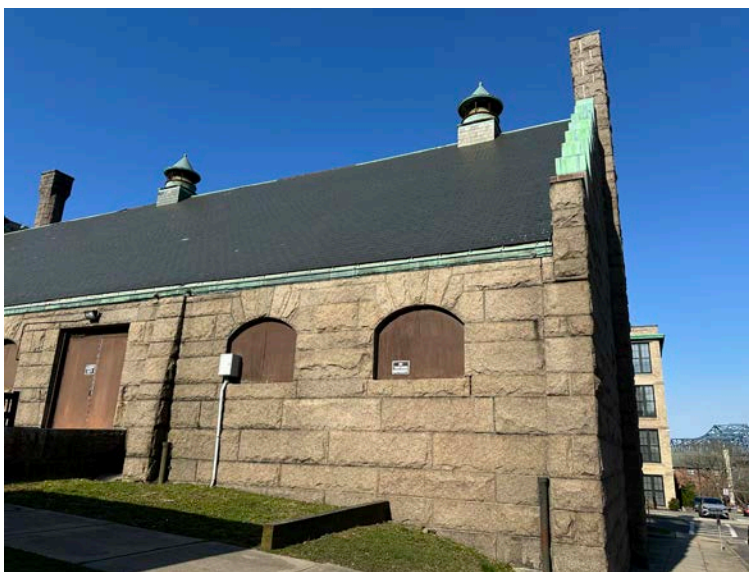
Figure 11 - Exterior Side (East Facing)

The granite blocks are generally intact, though there is visible surface weathering and localized erosion, particularly along the lower courses. Mortar joints appear recessed in several locations, suggesting gradual deterioration and loss of joint material over time. Some joints exhibit open gaps, especially along horizontal bedding planes, which may allow for water infiltration. No widespread repointing is evident, indicating that the mortar may be original or aged.

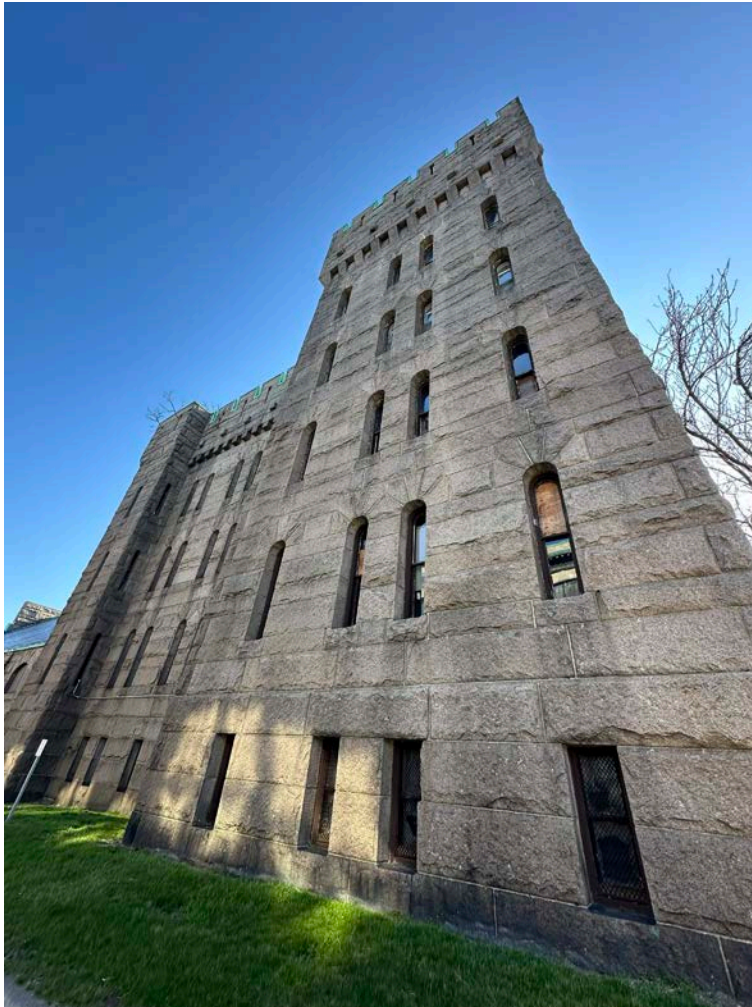
Figure 12 - Exterior Side (West Facing)

The masonry façade appears to be generally stable and in good overall condition, with no widespread structural distress evident from the ground-level observation. Localized areas of mortar deterioration are present, particularly at joints that exhibit erosion and loss of material. In several locations, mismatched mortar results in a visually inconsistent appearance that detracts from the historic character of the structure.

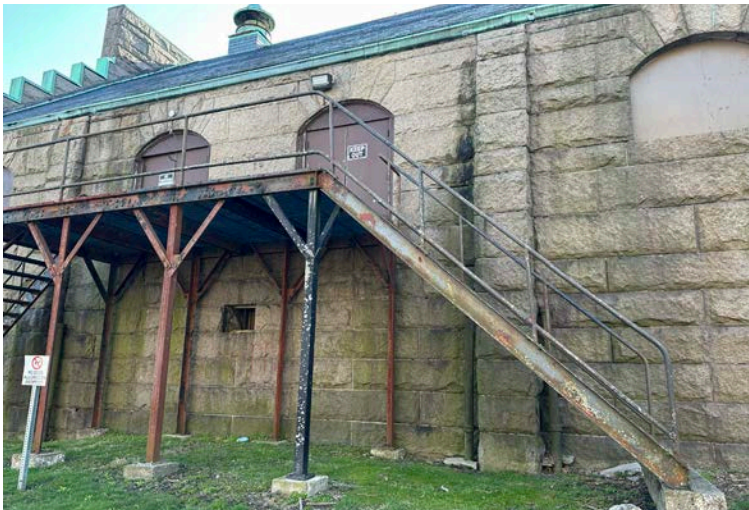
Figure 18 - Exterior Side (West Facing)

A prominent feature in the foreground is a steel egress stair and platform assembly attached to the wall. The steel structure exhibits advanced corrosion, particularly at stringers, railings, and connection points. Section loss is visible in some areas, and rust staining is evident on adjacent surfaces. The stair is supported by steel posts bearing on small concrete footings, which appear stable but minimally sized.

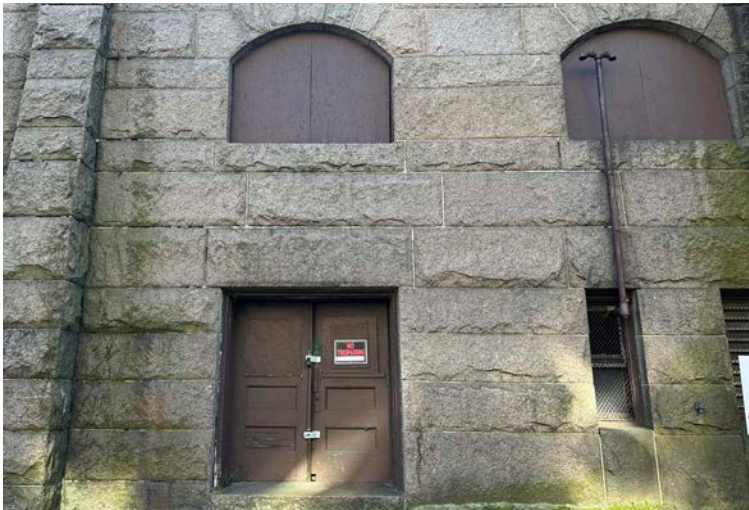
Figure 19 - Exterior Side (West Facing)

Several window openings along the wall have been infilled with plywood boards, which appear weathered but functional as temporary closures. The lack of glazing or permanent infill leaves these openings vulnerable to air and moisture infiltration, as well as potential pest entry.

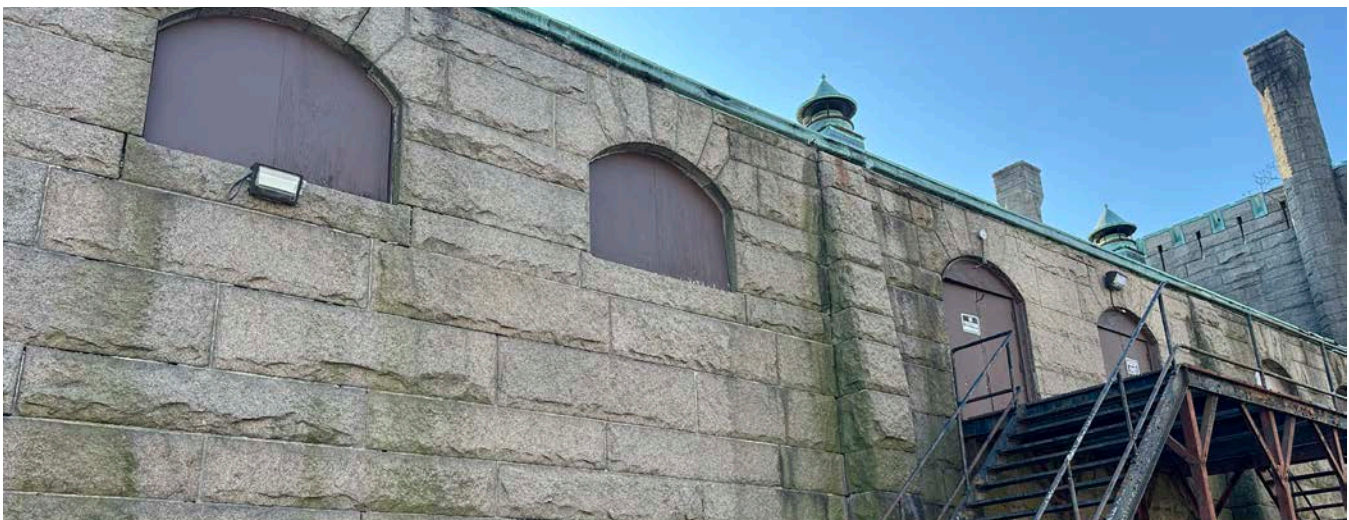
Figure 20 - Exterior Side (West Facing)

Mortar joints appear recessed in several locations and some joints exhibit open gaps, which may allow for water infiltration. No widespread repointing is evident, indicating that the mortar may be original or aged with spot repointing.

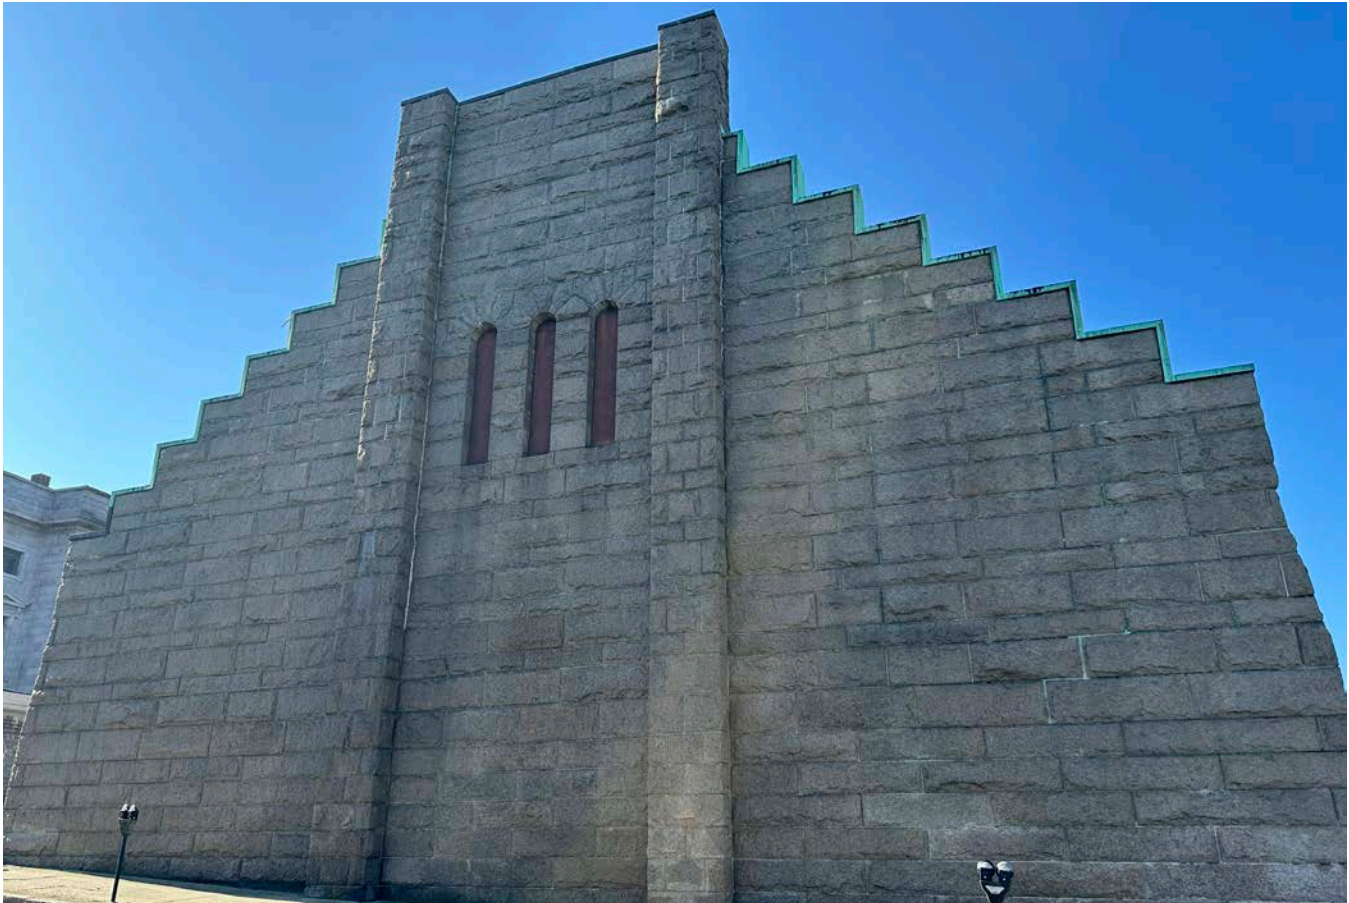
Figure 21 - Exterior Rear (North Facing)

The north façade appears to be in generally good overall condition, with the granite masonry exhibiting stability and no immediately evident signs of major structural distress from this vantage point. The stone units appear largely intact, with only minor surface weathering consistent with age and exposure. Mortar joints appear sound, but there are localized areas of repointing where the grout is visibly mismatched in color, texture, and tooling. These repairs are not historically accurate and detract from the visual cohesion of the façade.

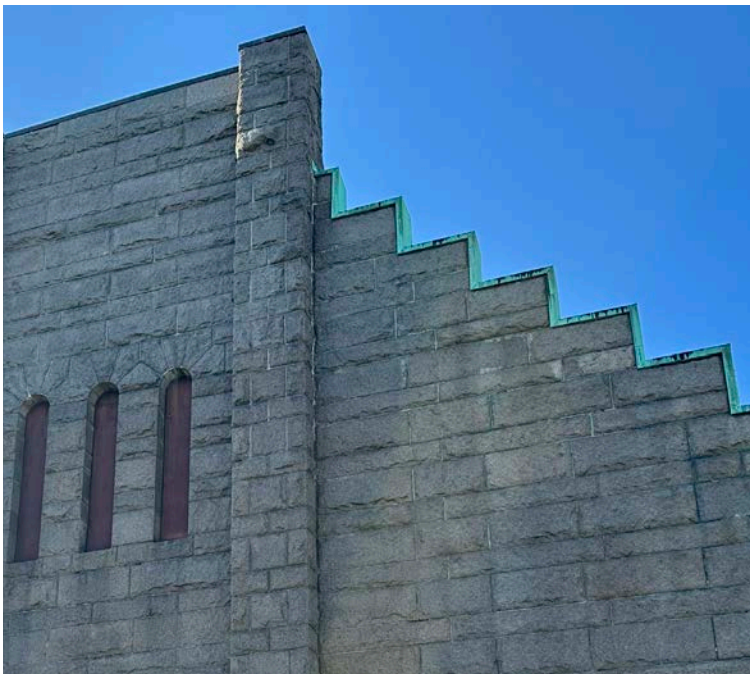
Figure 22 - Exterior Rear (North Facing)

The stepped parapet and vertical buttress elements appear plumb and well-maintained, with no obvious displacement. The window openings are sealed, and no active deterioration is apparent.

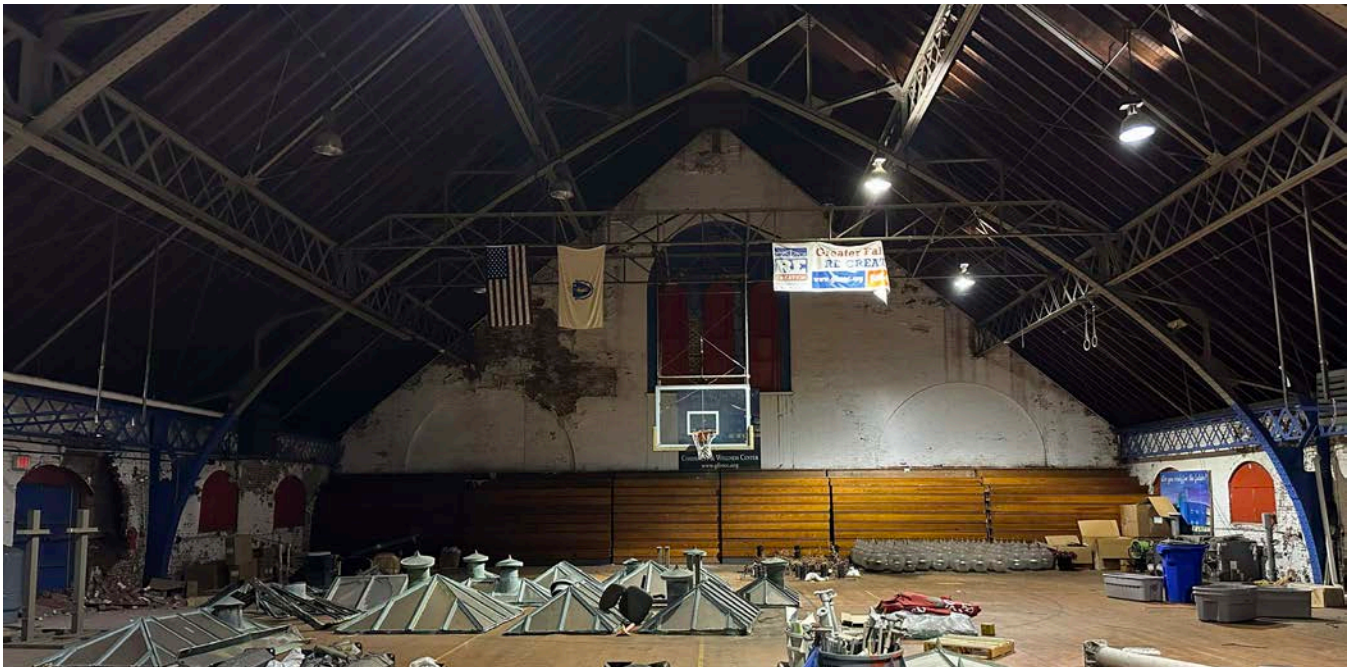
Figure 23 - Drill Hall (Rear)

The interior of the Drill Hall appears to be generally dry and structurally stable at the time of observation. The hardwood court flooring is intact and level, with no visible signs of buckling, cupping, or staining that would typically indicate prolonged moisture infiltration. Surface debris and stored materials are present across the floor, but these do not appear to have caused damage to the flooring itself.

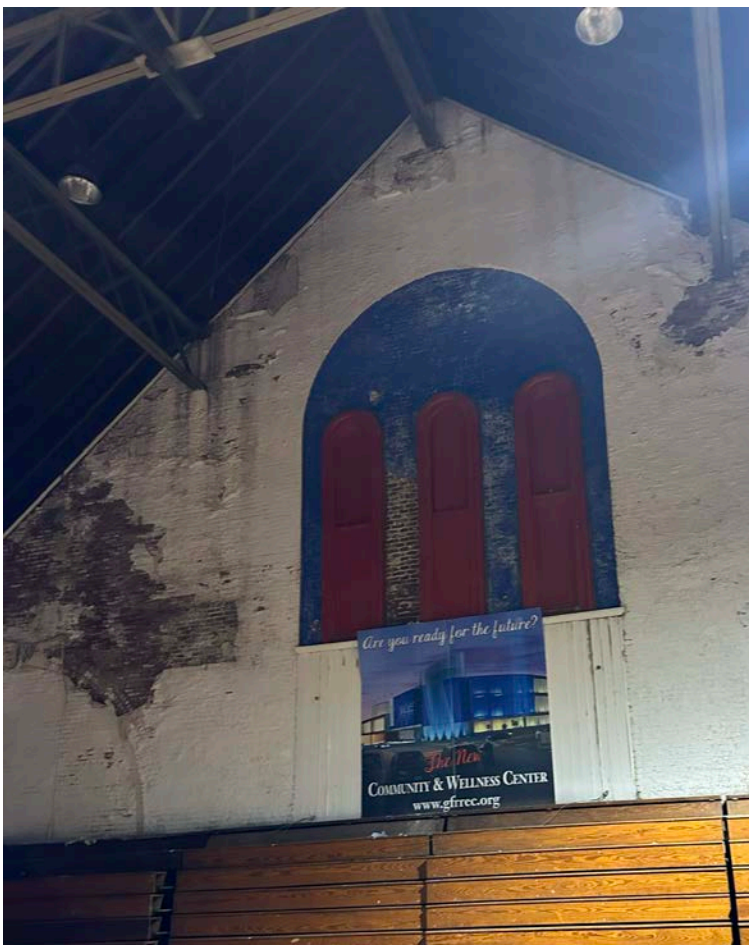
Figure 24 - Drill Hall (Rear)

At the north end of the hall, the three primary window openings are boarded over. However, there is visible evidence of past or intermittent moisture intrusion concentrated along portions of the adjacent masonry wall and near the roof line above. This is indicated by discoloration, staining, and localized deterioration of the interior brick and finishes. The moisture presence appears limited to specific areas rather than widespread, suggesting isolated entry points rather than systemic failure.

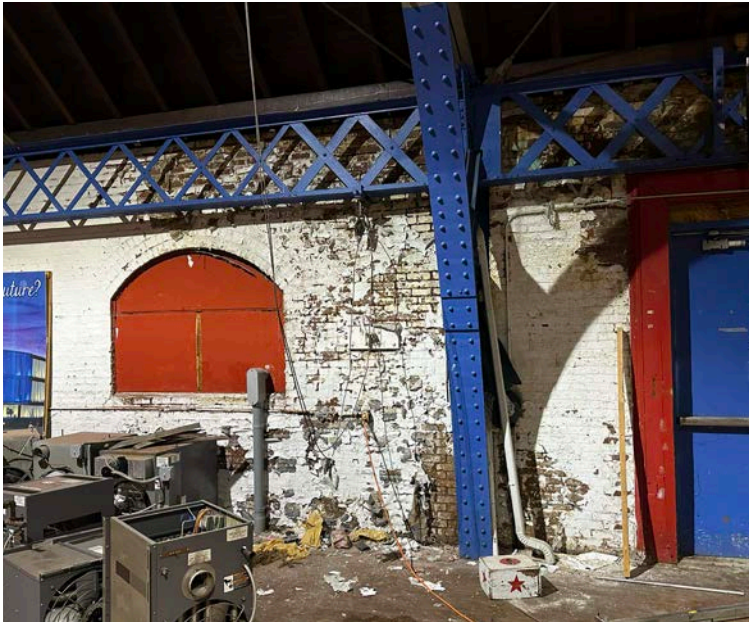
Figure 25 - Drill Hall (East)

The interior masonry wall shows extensive evidence of moisture-related damage with the painted masonry surface experiencing widespread delamination and loss of adhesion. Large sections of paint are peeling, flaking, and detaching from the substrate, exposing the underlying brick. This condition is consistent with prolonged moisture infiltration, likely from within the wall assembly. At the base of the wall, there is a significant accumulation of fallen paint chips, plaster-like debris, and masonry fragments, indicating ongoing material loss. This debris field suggests that deterioration is active rather than historic. The presence of shelving directly below the damaged wall may also be contributing to debris accumulation and could be at risk of contamination or damage.

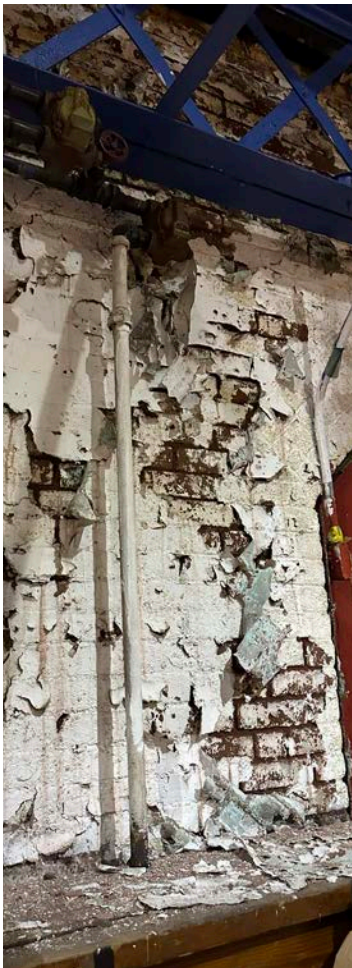
Figure 26 - Drill Hall (East)

Several vertical and horizontal pipes are mounted directly to the wall. These pipes show signs of corrosion, aging, and potential active or past leakage at joints and valves. The mounting penetrations and lack of proper sealing around these elements may be allowing water intrusion into the masonry assembly.

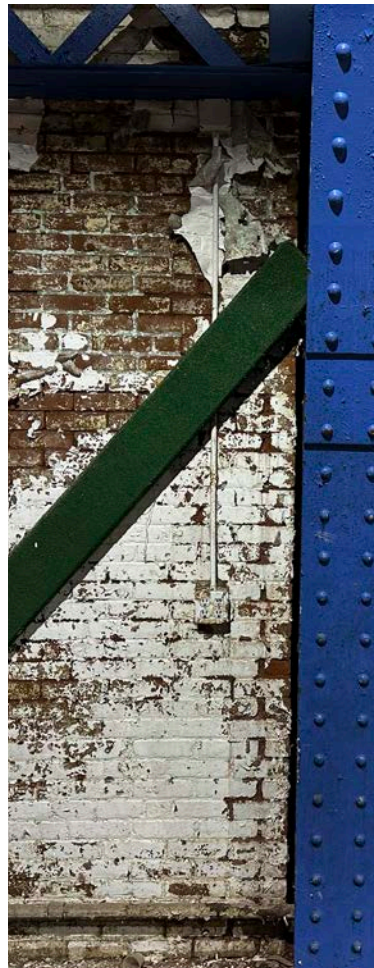
Figure 27 - Drill Hall (West)

The exposed brickwork shows areas of surface erosion and mortar joint deterioration, with localized loss of joint material. Efflorescence and staining are visible across portions of the wall, further indicating chronic moisture presence.

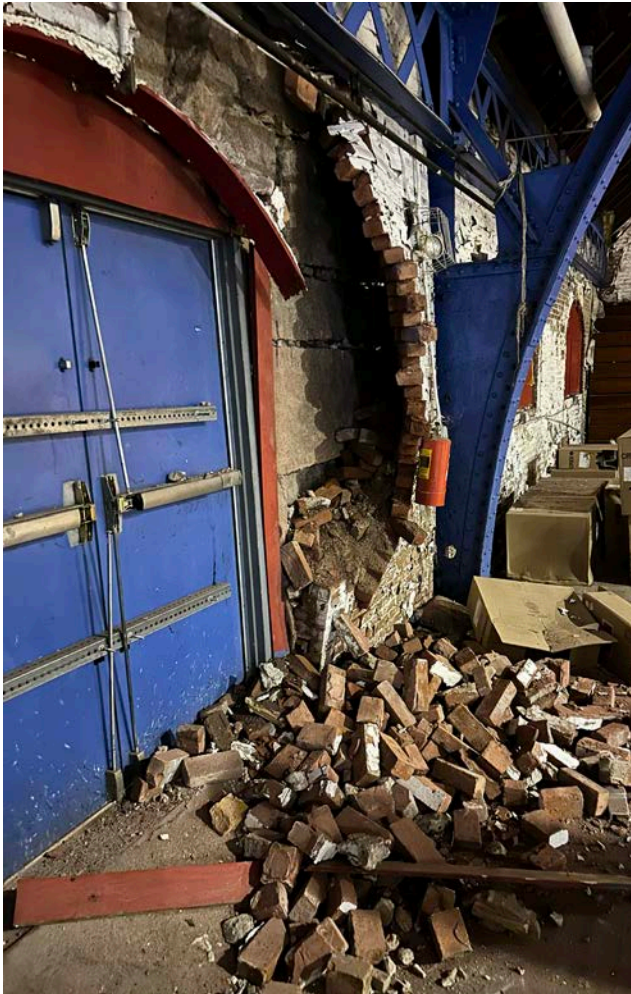
Figure 28 - Drill Hall (West)

A new, significant localized failure of an interior masonry wall was observed. The conditions indicate both acute structural distress and broader material deterioration. The most prominent condition is the partial collapse of a brick infill wall section adjacent to a large arched opening with double doors. A section of brick masonry has dislodged and fallen to the floor. The arched openings along the wall, including the one immediately adjacent to the collapse, appear to remain intact; however, there are visible gaps and the surrounding masonry shows signs of stress, including cracking and separation at joints. The stability of these arches may be compromised if the adjacent wall sections continue to deteriorate. Overhead, the steel structural framing (painted blue) appears generally intact and not visibly deformed. There is no immediate visible distortion in the steel members, but their reliance on the masonry for bracing should be evaluated. The presence of utilities (conduits and piping) mounted along the wall may have introduced penetrations or localized weaknesses.

The failure appears to extend vertically from near floor level to above the spring line of the adjacent arch, indicating a loss of structural integrity across a significant height of the wall. The interface between the remaining brick masonry and the exposed backing appears poorly bonded, which may have contributed to the detachment and collapse. The painted brick surfaces show peeling, flaking, and loss of adhesion, indicating prolonged moisture exposure.

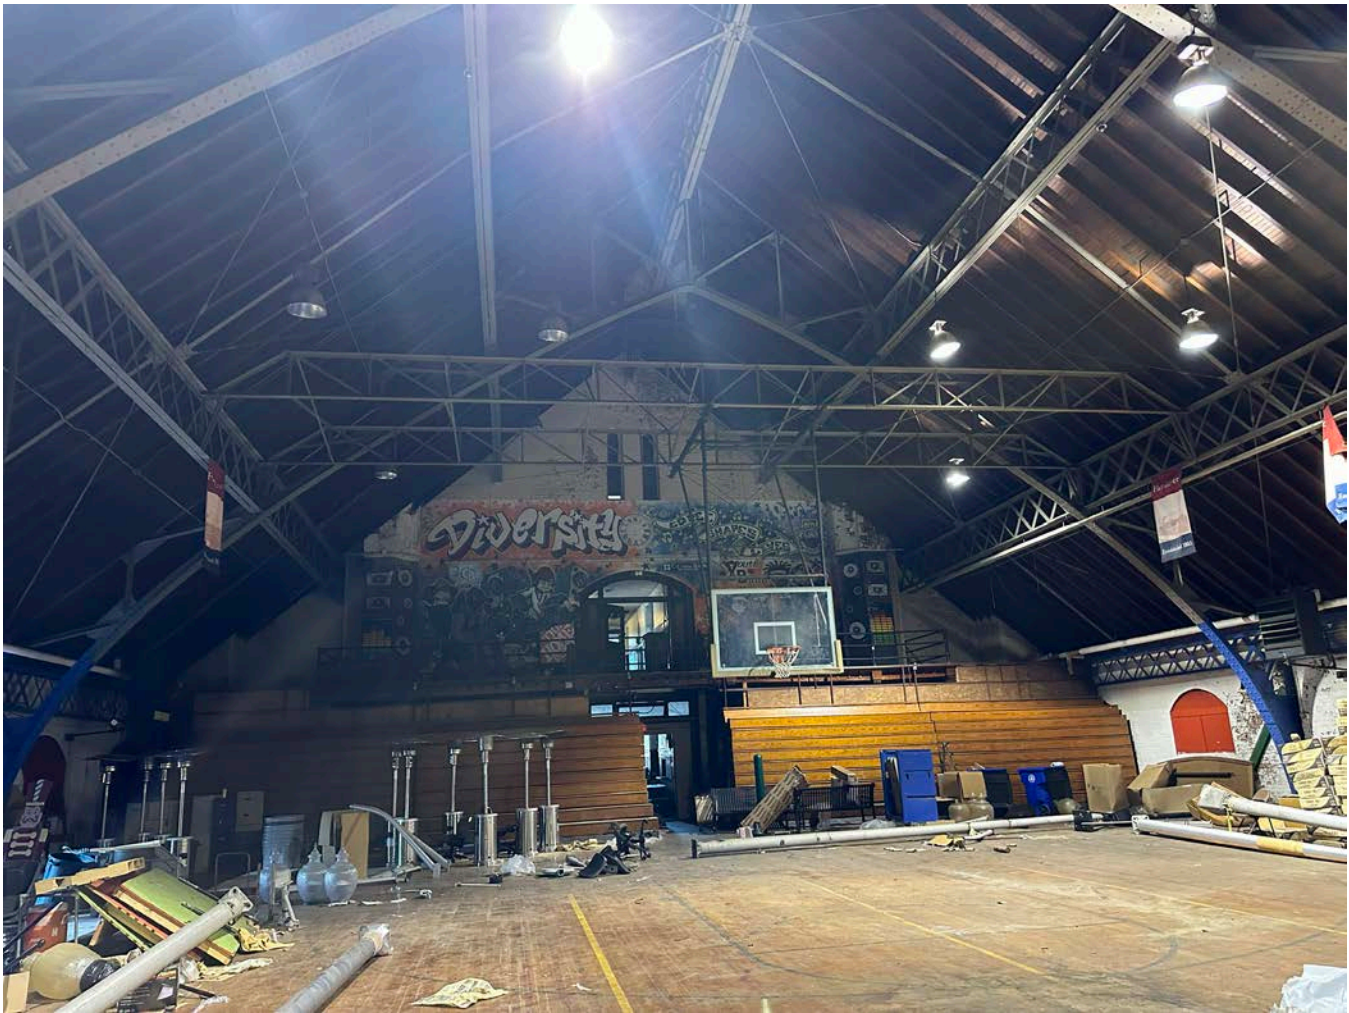
Figure 32 - Drill Hall (South)

The interior north wall of the Drill Hall appears in fair condition with less signs of water intrusion than the opposite wall,

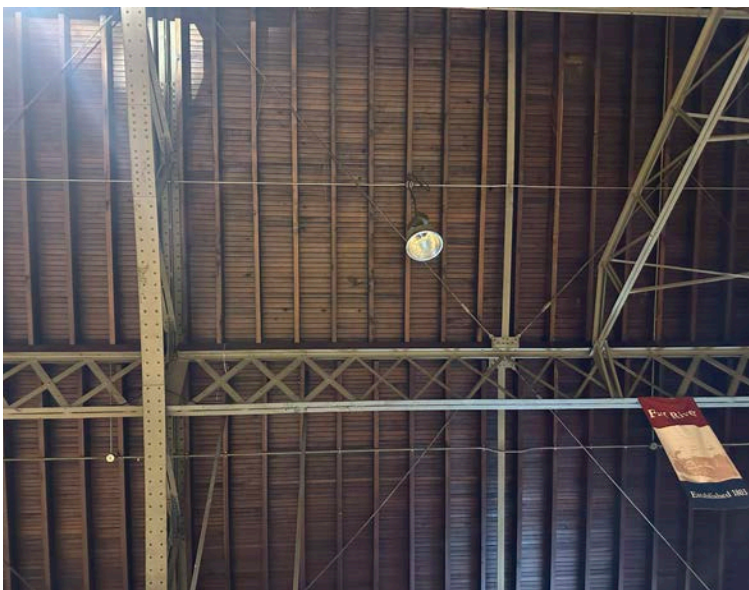
FIGURE 33 - DRILL HALL (CEILING)

The interior ceiling of the Drill Hall appears to remain in good overall condition following the roof replacement completed under the FY18 CPA grant. The exposed wood decking is uniformly intact, with no visible signs of active moisture infiltration such as staining, discoloration, warping, or biological growth. The consistent tone and condition of the wood boards suggest that the roof system above is effectively shedding water and protecting the structure below.

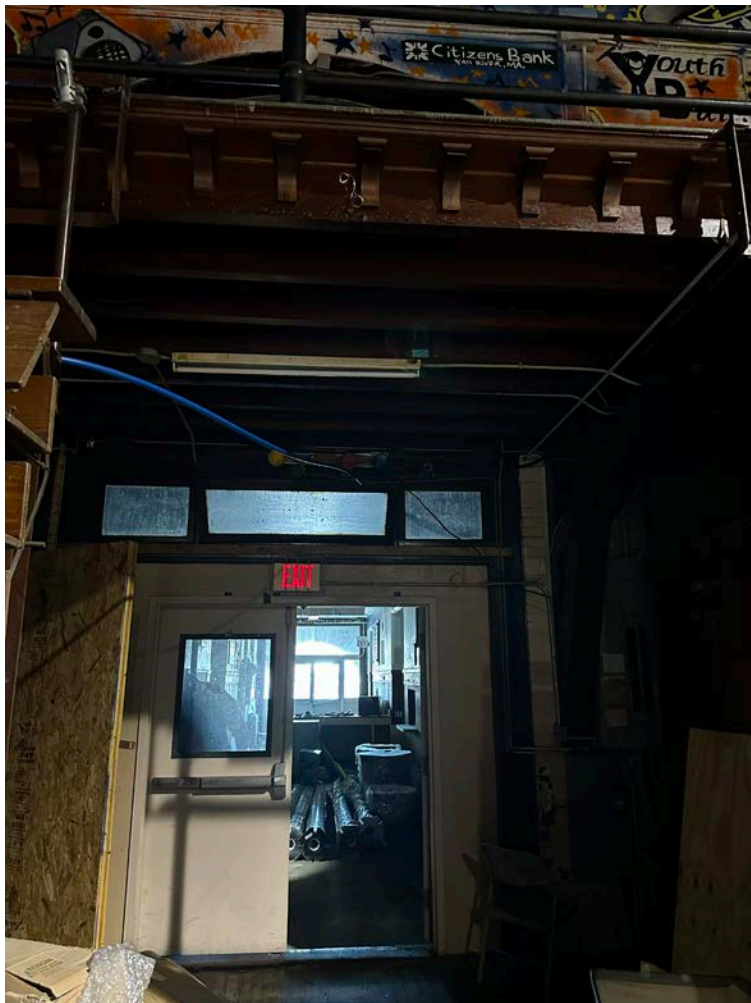
Figure 35 - Drill Hall (South)

The architectural features above the main doorway into the Armory building from the Drill Hall remain intact with no signs of water infiltration. The architectural features above the doorway — most notably the exposed wood beam, decorative corbels, and supporting members — appear to remain intact and structurally sound. The wood elements show no visible signs of active deterioration such as warping, staining, rot, or biological growth, which would typically indicate moisture intrusion. The finishes appear consistent in color, suggesting that these elements have remained largely dry over time. There are no observable signs of water infiltration at the beam or adjacent ceiling areas. Specifically, there is an absence of discoloration, efflorescence, peeling finishes, or staining patterns that would typically result from prolonged moisture exposure. The connection points between the beam and surrounding materials also appear tight and undisturbed, with no visible separation or cracking that might suggest movement or water-related damage. The doorway assembly below, including the frame, transom window, and adjacent wall surfaces, also appears free of moisture-related distress. The transom glazing is intact, and while slightly obscured, it does not exhibit signs of condensation buildup or water staining.

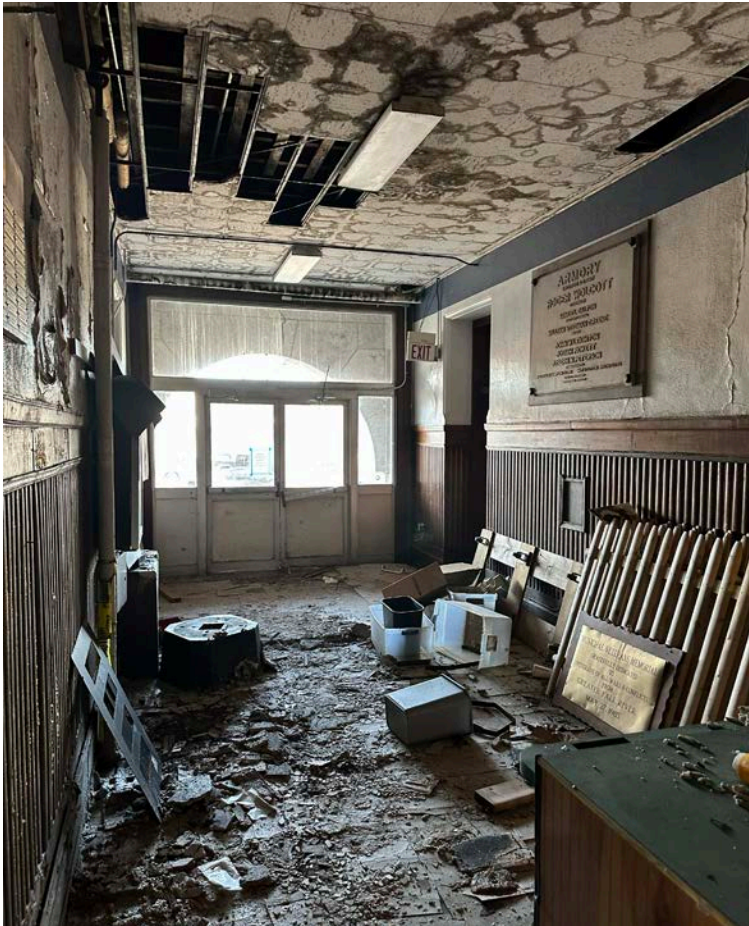
Figure 36 - First Floor (Main Hallway)

The interior entry corridor is in severely deteriorated condition, with the most significant damage observed at the ceiling. Large sections of the ceiling have failed, exposing framing and mechanical systems above, while remaining surfaces exhibit extensive water staining, delamination, and active deterioration. The floor is heavily covered with debris from ceiling collapse, indicating continuous material loss rather than a single failure event.

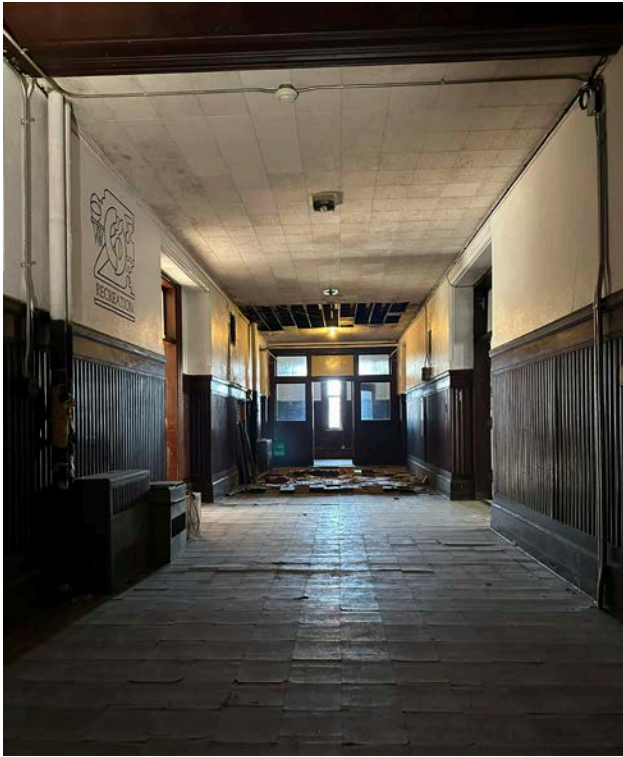
Figure 48 - Second Floor (Main Hallway)

The corridor exhibits extensive deterioration consistent with significant past water infiltration originating at the roof level and migrating downward through multiple floors.

The most severe damage is concentrated directly beneath the apparent path of infiltration, where large sections of the finished ceiling have failed. Portions of the ceiling assembly are missing entirely, exposing wood joists and framing members above. The finished tile flooring has experienced substantial displacement and failure, with widespread buckling, heaving, and breakage. Numerous tiles are fractured or fully dislodged. The deformation of the floor suggests prolonged saturation of the subfloor materials, likely resulting in expansion, loss of structural integrity, and eventual collapse of the finished surface in localized areas. Painted plaster wall surfaces exhibit minor staining and possible moisture-related degradation, while the wood wainscoting remains largely in place, though its long-term condition may be compromised.

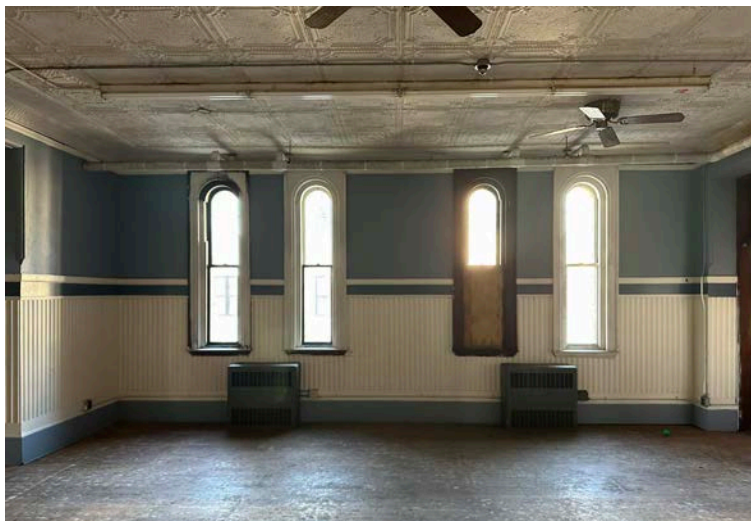
Figure 52 - Second Floor (West)

The decorative tin ceiling remains largely intact. However, there are localized areas where paint deterioration, discoloration, and minor surface degradation are present. The absence of sagging panels or significant deformation indicates that the ceiling system remains structurally stable.

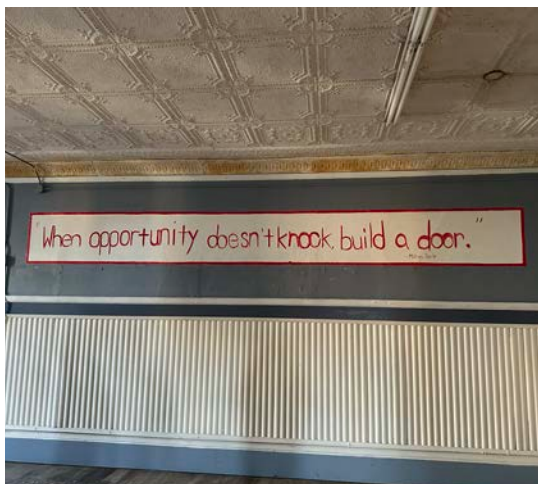
Figure 53 - Second Floor (West)

The wooden millwork of the former offices and classrooms are in good condition. One glass storm window is not properly attached.

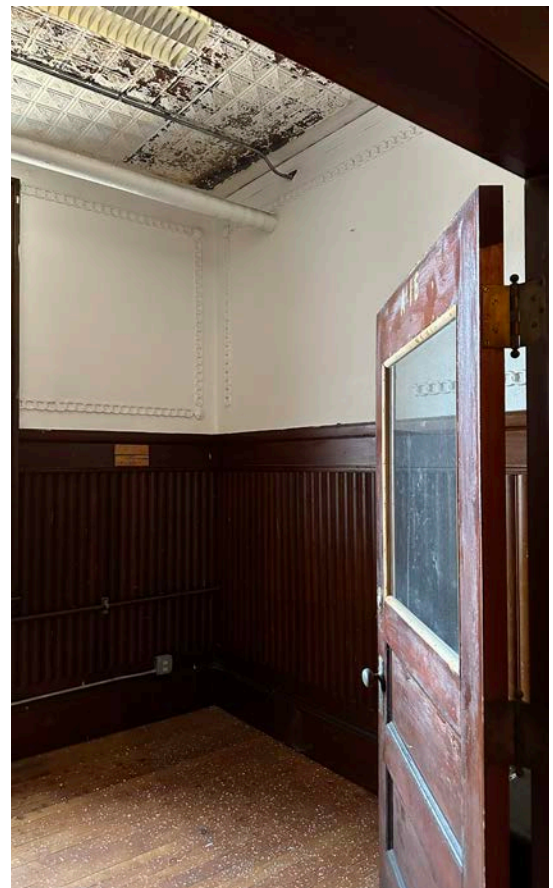
Figure 62 - Second Floor (East)

The paint on the tin ceiling in the east side of the second floor showed signs of cracking and chipping, possibly from moisture infiltration.

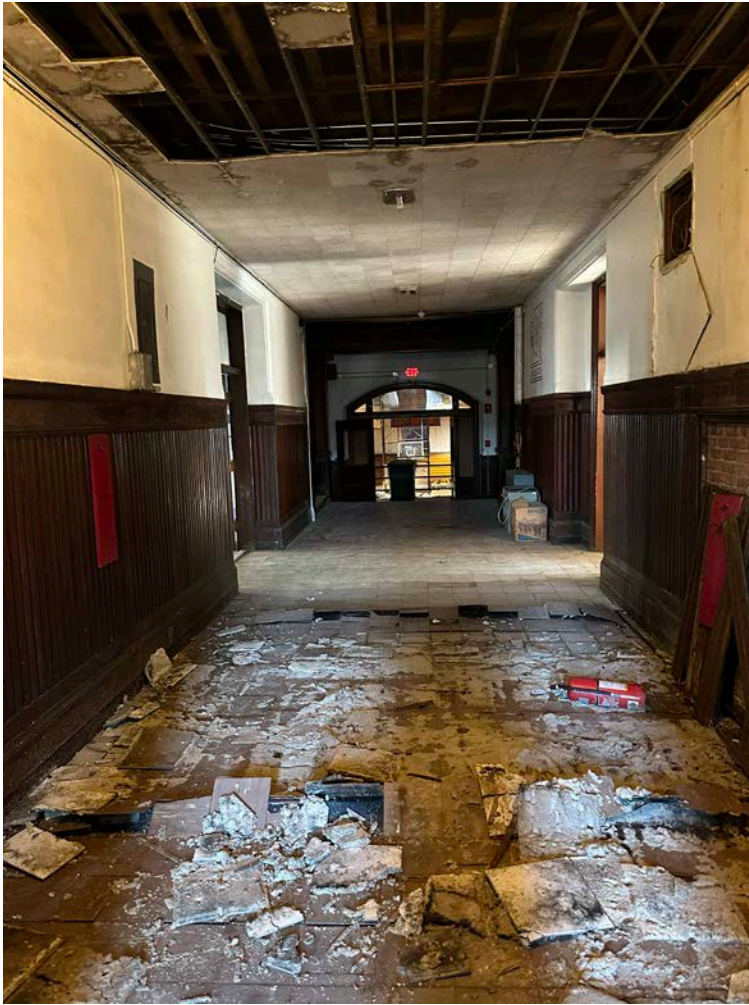
**FIGURE 63 - SECOND FLOOR (MAIN HALLWAY)**

No signs of new damage or water infiltration.

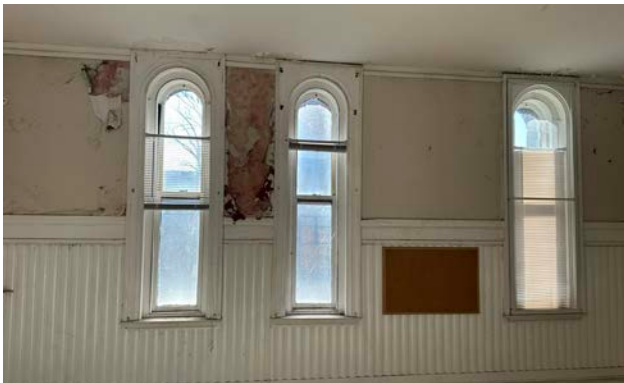
Figure 81 - Third Floor (Southeast)

Along the exterior wall, particularly around and between the arched window openings, there is visible cracking and localized material loss. The condition of the wall surface suggests repeated wetting and drying cycles, which may have contributed to the cracking and delamination observed.

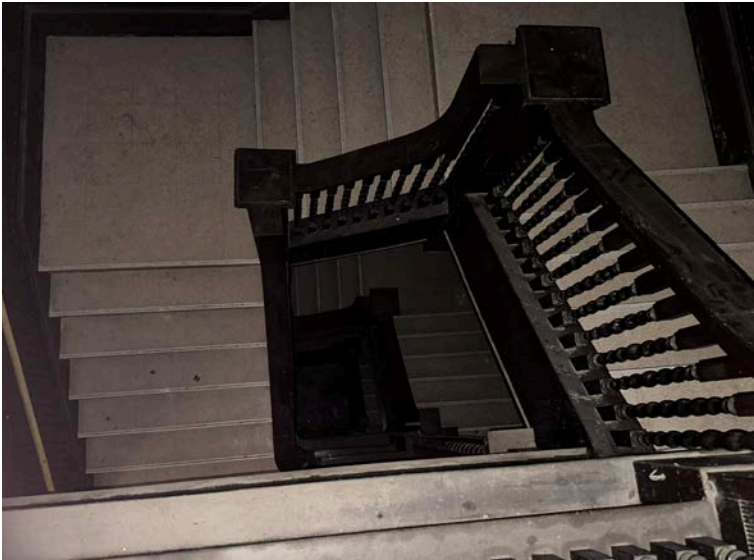
Figure 86 - Fourth Floor (Stairwell)

**FIGURE 86 - FOURTH FLOOR (STAIRWELL)**  
The stairwell to the fourth floor appeared in stable condition with no signs of water damage to any of the wooden bannisters.
