# BANK STREET ARMORY

## PRELIMINARY EXISTING CONDITIONS REPORT

72 Bank Street  
Fall River, MA

Prepared by the Preservation Society of Fall River, Inc.

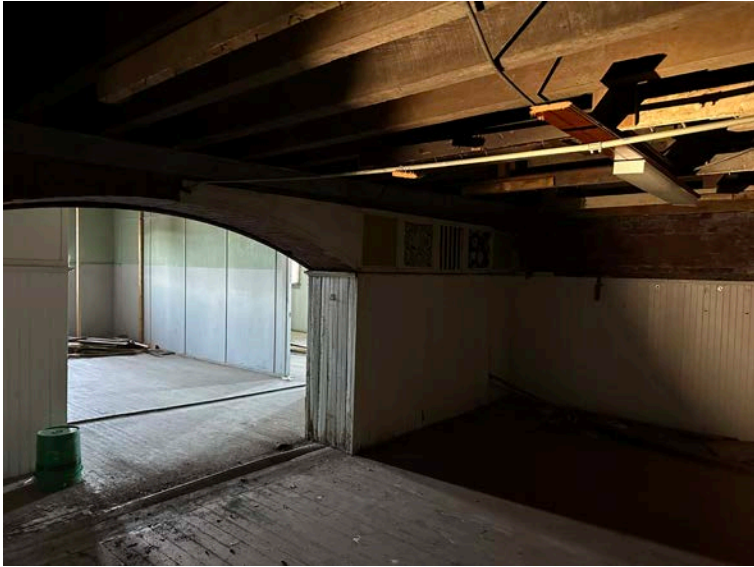
Figure 87 - Fourth Floor (Main Hallway)

**FIGURE 87 - FOURTH FLOOR (MAIN HALLWAY)**  
The landing area for the stairwell on the fourth floor appeared dry and in stable condition.

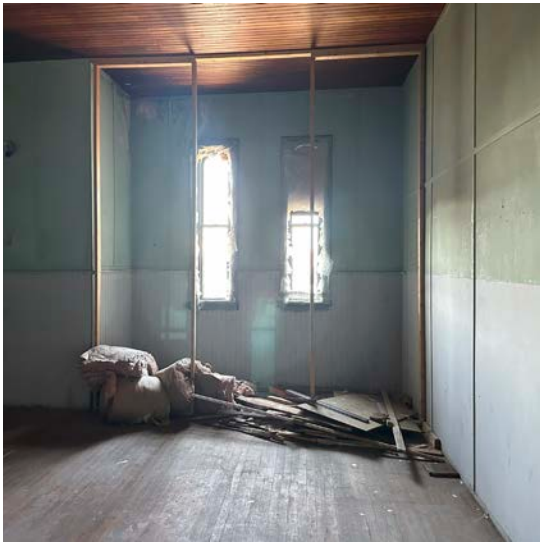
Figure 89 - Fourth Floor (Southwest)

**FIGURE 89 - FOURTH FLOOR (SOUTHWEST)**  
The weatherproofing for the windows in the southwest corner of the fourth floor has failed, but there were limited signs of moisture infiltration or new damage.

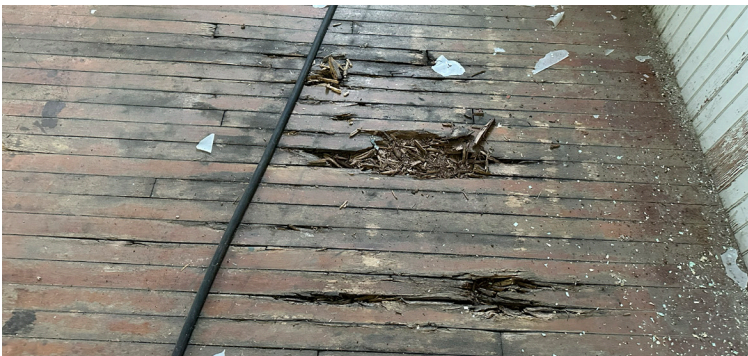
Figure 91 - Fourth Floor (Southwest)

The hardwood flooring in the southwest corner exhibits localized, but significant, deterioration consistent with prolonged moisture exposure. Several floorboards show advanced rot, with sections fully deteriorated and missing, exposing fragmented and splintered wood beneath. The damaged areas appear concentrated along a linear path, suggesting repeated water intrusion.

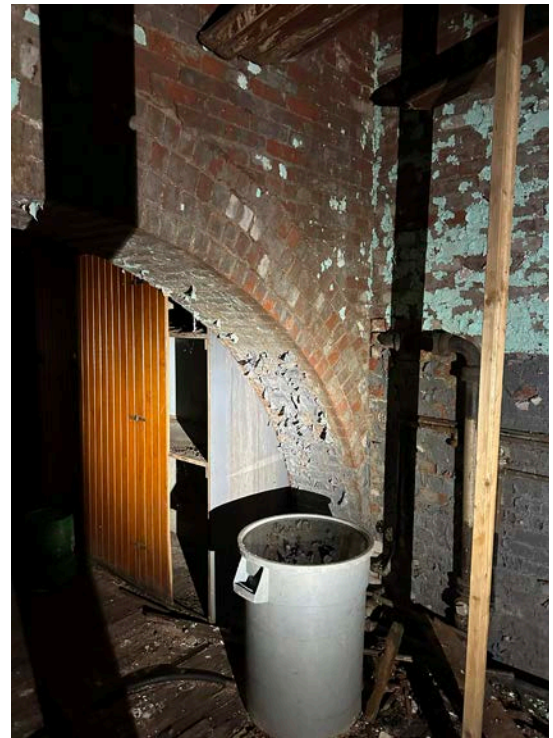
Figure 95 - Fourth Floor (South)

Signs of moisture intrusion at the windows, which are improperly weatherproofed. Observations include discoloration around the wall and window sills as well as bubbling of the paint.
