# BANK STREET ARMORY

## PRELIMINARY EXISTING CONDITIONS REPORT

72 Bank Street  
Fall River, MA

Prepared by the Preservation Society of Fall River, Inc.

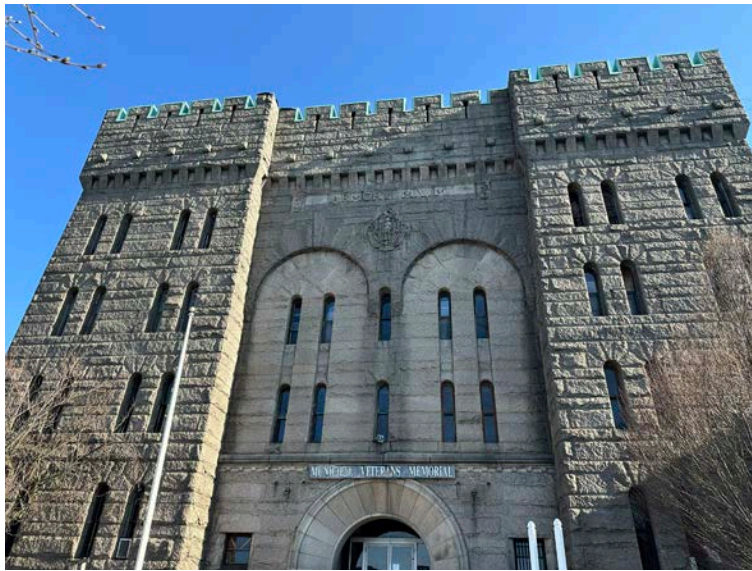
Figure 1 - Exterior Front (South Facing)

## FIGURE 1 - EXTERIOR FRONT (SOUTH FACING)

The front façade of the Bank Street Armory appears to remain in generally fair and stable condition, particularly when compared to conditions documented in the 2015 study. The building’s Romanesque Revival masonry construction appears largely intact, with no immediately visible signs of significant structural displacement or widespread material failure. Consistent with prior observations, there remain several damaged or missing windows, which have been temporarily secured with boarding. Encroaching vegetation in close proximity to the south side of the building façade, may also contribute to moisture retention.

The stone façade shows localized weathering and minor surface deterioration, consistent with age and long-term exposure, though the overall integrity of the masonry units and mortar joints appears to be holding. The crenellations and upper wall sections do not exhibit obvious deformation or loss.

It was observed that a section of the copper flashing along the roof line of the primary façade has become detached and displaced, specifically along the crenellated parapet. The flashing appears lifted and uneven in one section, exposing underlying joints and creating a potential point of water infiltration. Given the building’s rusticated stone construction and pronounced horizontal ledges, this condition may allow moisture to penetrate behind the masonry, accelerating deterioration of mortar joints and contributing to freeze-thaw damage. The remainder of the southern roof edge appears generally intact from this vantage point.

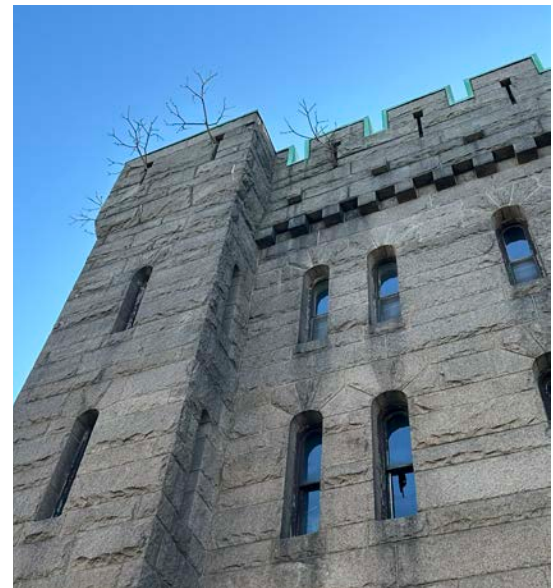
Figure 14 - Exterior Side (West Facing)

## FIGURE 14 - EXTERIOR SIDE (WEST FACING)

Vegetative growth is present along the parapet level, including small plants and saplings that persist despite prior removal efforts. This recurring growth is likely facilitated by organic debris accumulation and exacerbated by frequent bird activity — particularly seagulls — which contribute to seed dispersal and nutrient deposits.

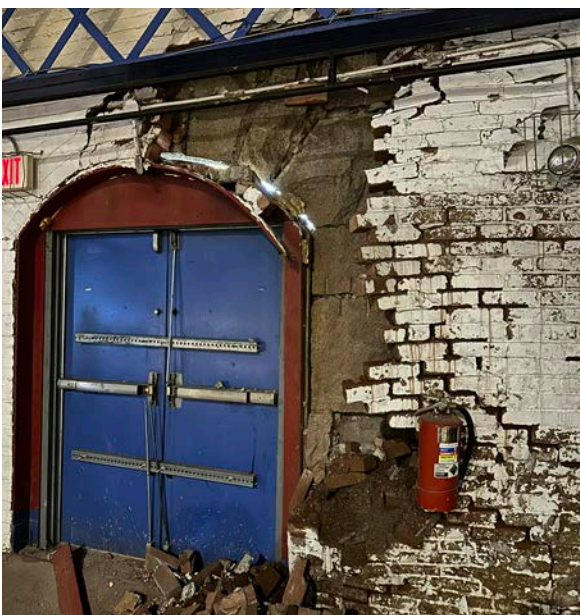
Figure 29 - Drill Hall (West)

FIGURE 29 - DRILL HALL (WEST)

The failure appears to extend vertically from near floor level to above the spring line of the adjacent arch, indicating a loss of structural integrity across a significant height of the wall. The interface between the remaining brick masonry and the exposed backing appears poorly bonded, which may have contributed to the detachment and collapse. The painted brick surfaces show peeling, flaking, and loss of adhesion, indicating prolonged moisture exposure.

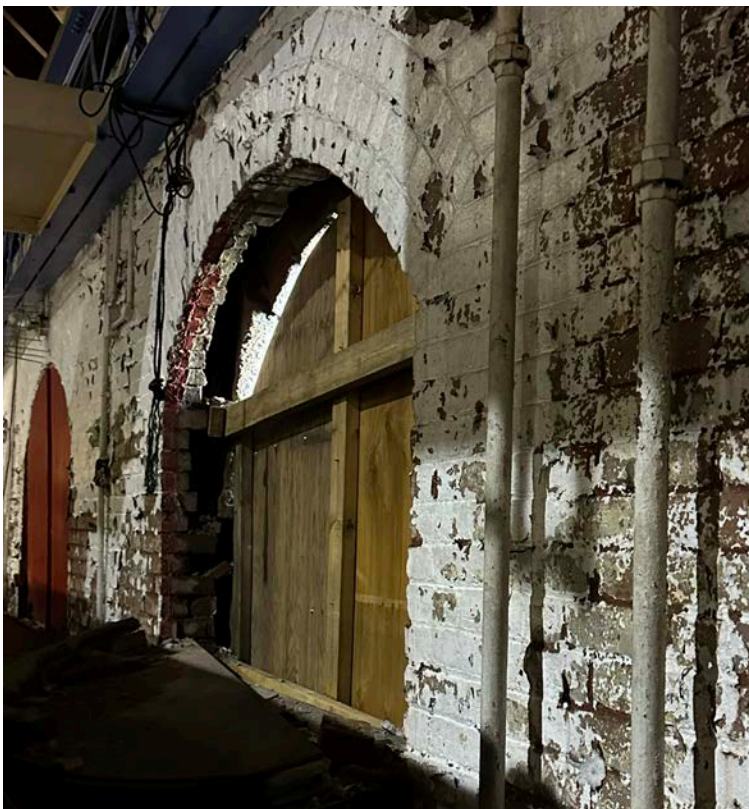
Figure 31 - Drill Hall (West)

**FIGURE 31 - DRILL HALL (WEST)**

Consistent with the observed conditions, there are clear openings between the infilled framing and the surrounding masonry, allowing daylight to penetrate into the interior space. These gaps indicate a compromised building envelope and suggest pathways for water infiltration, air movement, and potential pest entry. Of particular concern is the apparent configuration of the lintel above the opening. The lintel appears to be angled downward toward the interior rather than sloped outward. This improper pitch likely facilitates water drainage into, rather than away from, the wall assembly. Over time, this condition would contribute to moisture intrusion within the masonry, accelerating the breakdown of mortar joints, paint failure, and potential brick deterioration.

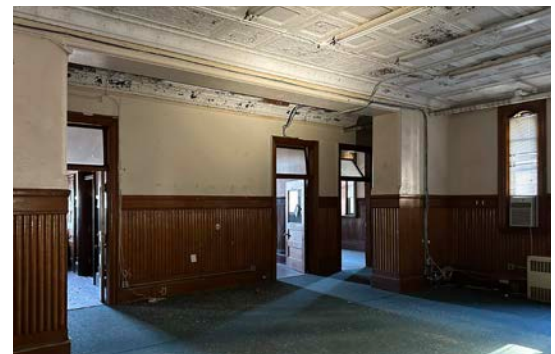
Figure 39 - First Floor (West)

FIGURE 39 - FIRST FLOOR (WEST)

Signs of paint flaking and on the tin-ceiling.

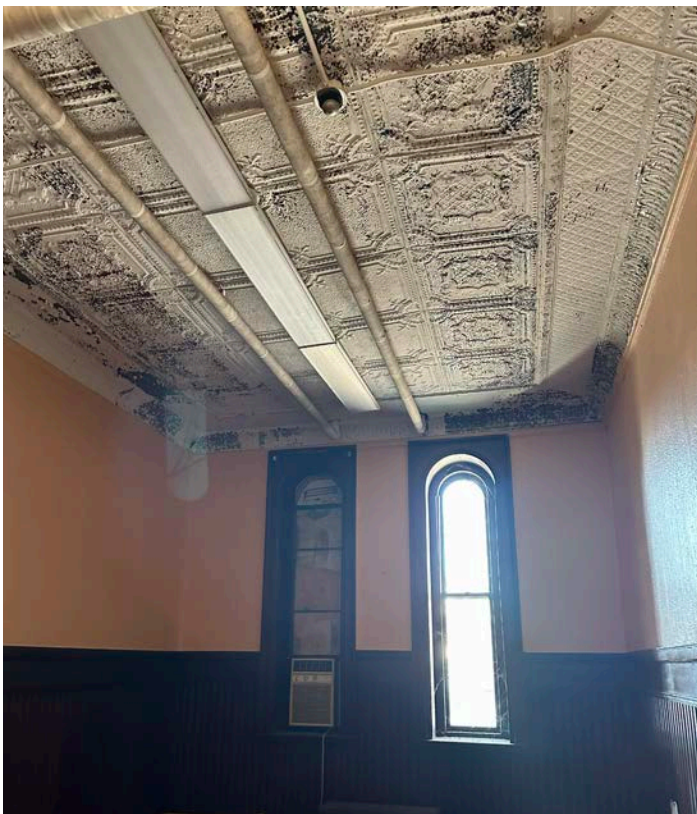
Figure 42 - First Floor (Southwest)

**FIGURE 42 - FIRST FLOOR (SOUTHWEST)**

There is widespread deterioration of the paint finish and the coating exhibits extensive chipping, flaking, and loss of adhesion, exposing the underlying metal substrate in many areas. Given the age of the building and the type of finish, the deteriorated coating may contain lead-based paint.

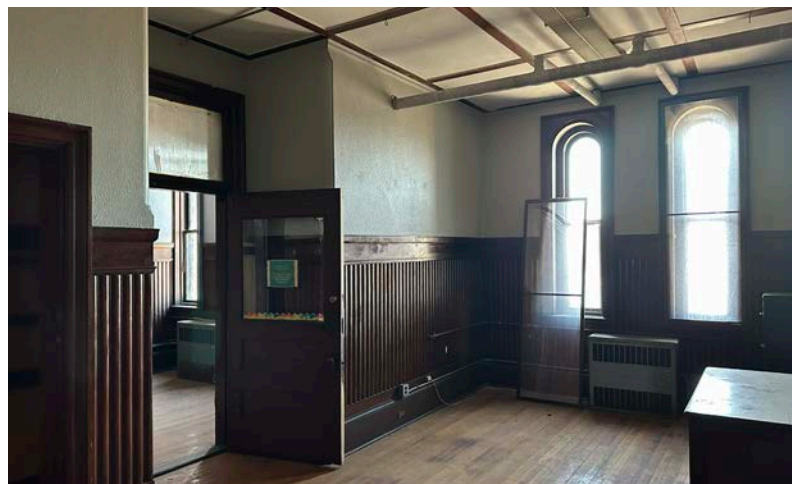
Figure 54 - Second Floor (Southwest)

FIGURE 54 - SECOND FLOOR (SOUTHWEST)

The wooden millwork of the former offices and classrooms are in good condition. One glass storm window is not properly attached.

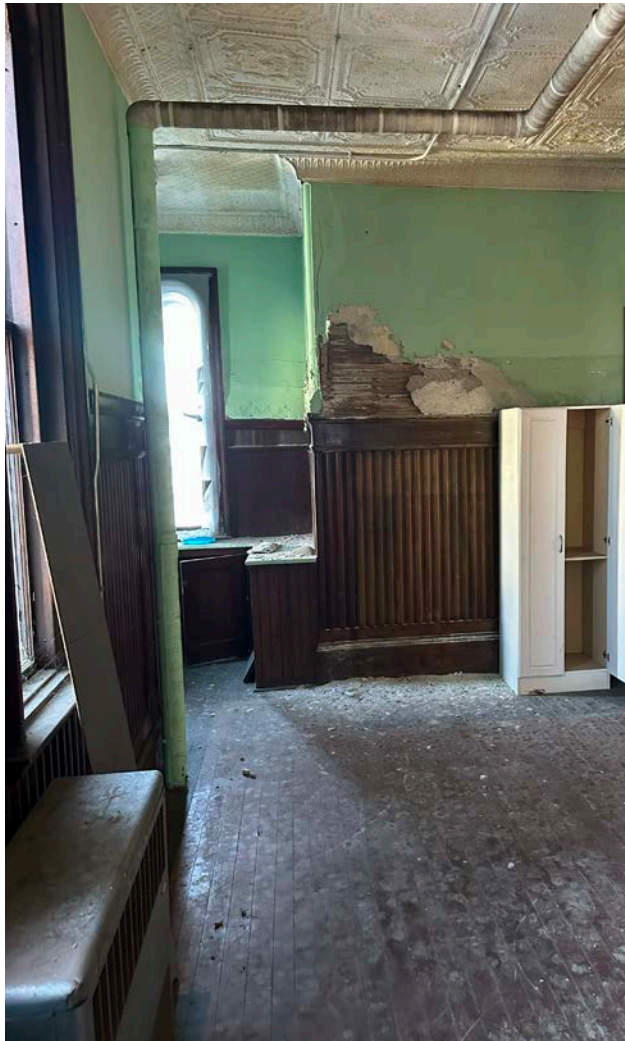
Figure 56 - Second Floor (West)

## FIGURE 56 - SECOND FLOOR (WEST)

A section of plaster has failed and detached from the wall, exposing the underlying wood lath system. The failure appears irregular in shape and is most pronounced above the wood wainscoting. The wood wainscoting below appears relatively intact but may be concealing additional concealed deterioration within the wall cavity.

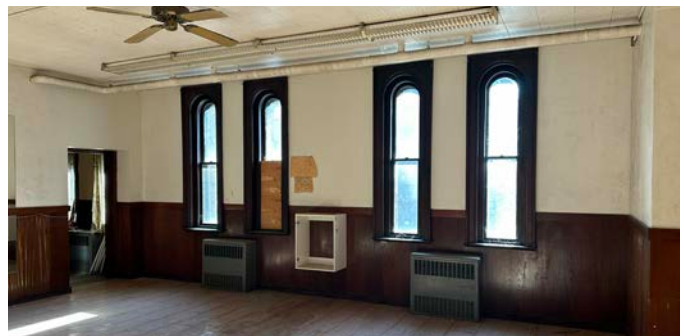
Figure 58 - Second Floor (East)

## FIGURE 58 - SECOND FLOOR (EAST)

The ceiling on the east side of the second floor did not show signs of recent water intrusion.

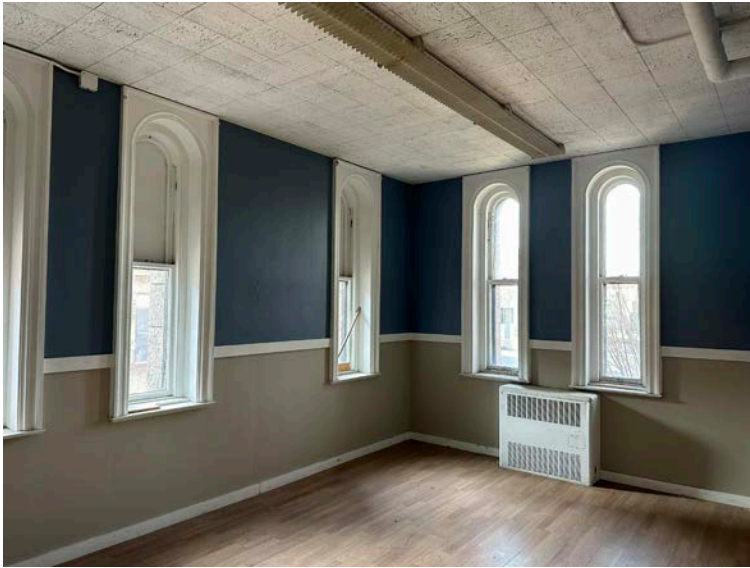
Figure 59 - Second Floor (Southeast)

**FIGURE 59 - SECOND FLOOR (SOUTHEAST)**

The ceiling on the southeast side of the second floor did not show any recent signs of water intrusion.

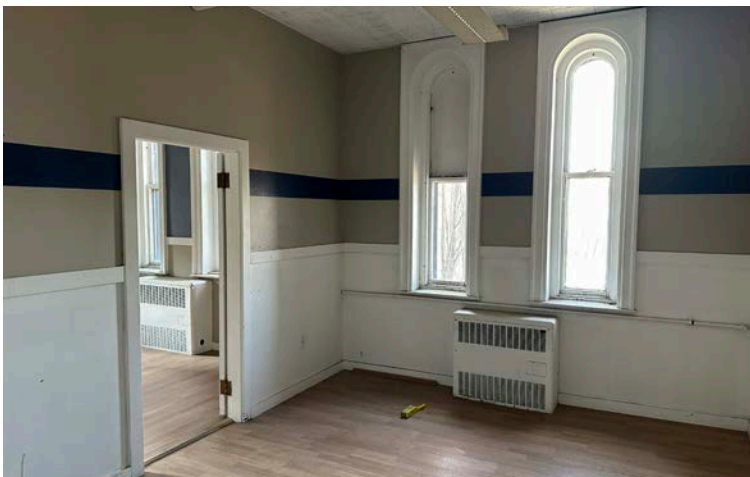
Figure 61 - Second Floor (Southeast)

**FIGURE 61 - SECOND FLOOR (SOUTHEAST)**

The ceiling and floor on the southeast side of the second floor did not show any recent signs of water intrusion.

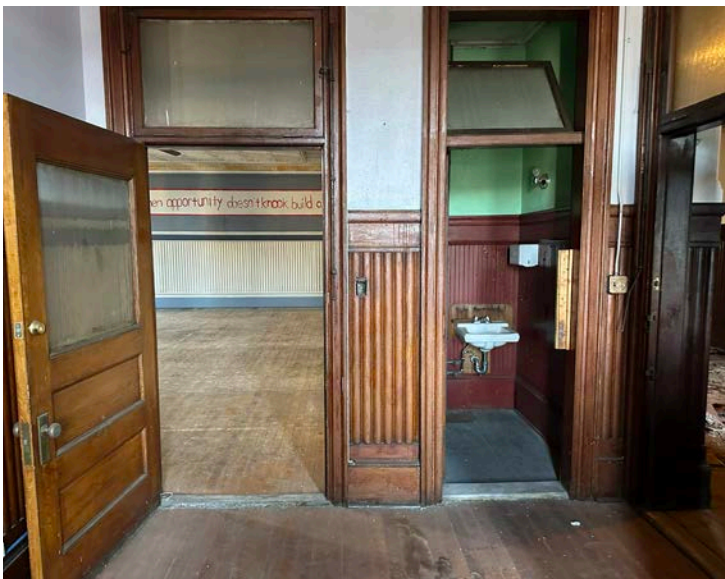
Figure 63 - Second Floor (Main Hallway)

**FIGURE 63 - SECOND FLOOR (MAIN HALLWAY)**

Wall surfaces and architectural finishes appear comparatively more intact but still show signs of environmental stress. Painted plaster exhibit minor staining and possible moisture-related degradation, while the wood wainscoting remains largely in place, though its long-term condition may be compromised.

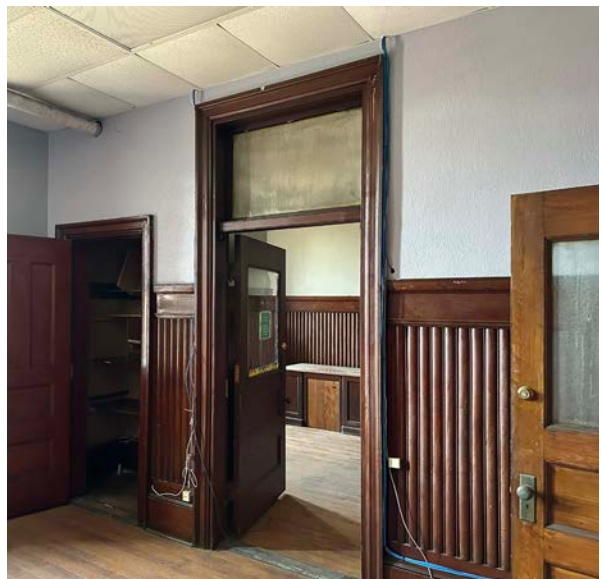
Figure 64 - Second Floor (West)

**FIGURE 64 - SECOND FLOOR (WEST)**

Original wood finishes, including paneled walls, door casings, and trim, all appear to remain intact and generally well-preserved. The wood elements show typical signs of age such as surface wear, minor scuffing, and finish dulling, but no significant deterioration, warping, or material failure is evident. The door to the left, including its hardware and glazing, appears functional and structurally sound, with no visible signs of moisture-related damage such as staining, swelling, or rot.

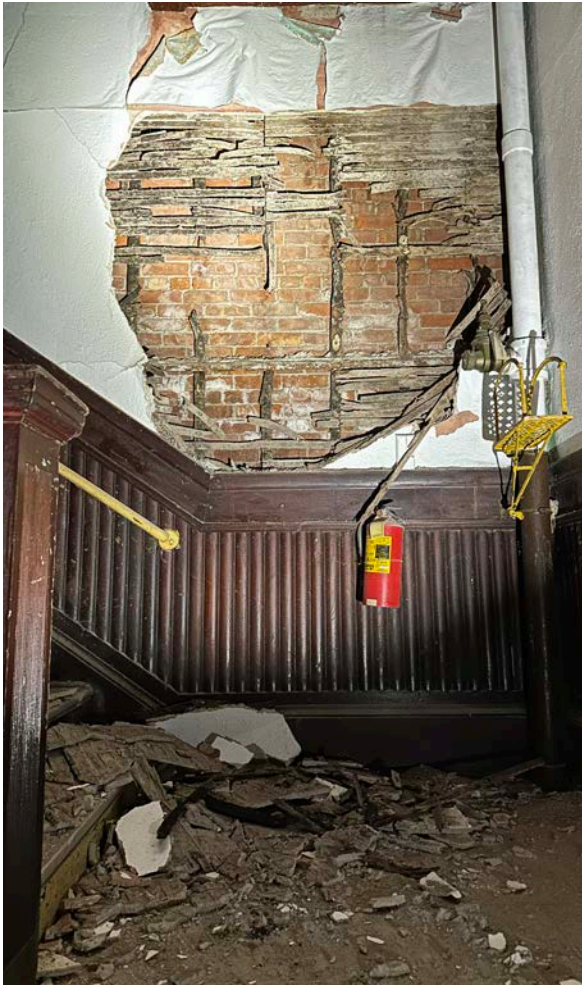
Figure 66 - Third Floor (Stairwell)

**FIGURE 66 - THIRD FLOOR (STAIRWELL)**

A new, significant localized failure of the interior plaster wall located along the stairwell leading to the third floor was observed. Approximately halfway up the stair run, a large section of plaster has detached and fallen away, exposing the underlying historic brick masonry and remnants of wood lath. The exposed substrate reveals aged brick masonry with visible mortar joints and embedded wood lath strips, many of which appear deteriorated, warped, or partially decayed. The condition of the lath suggests prolonged exposure to moisture and environmental fluctuations.

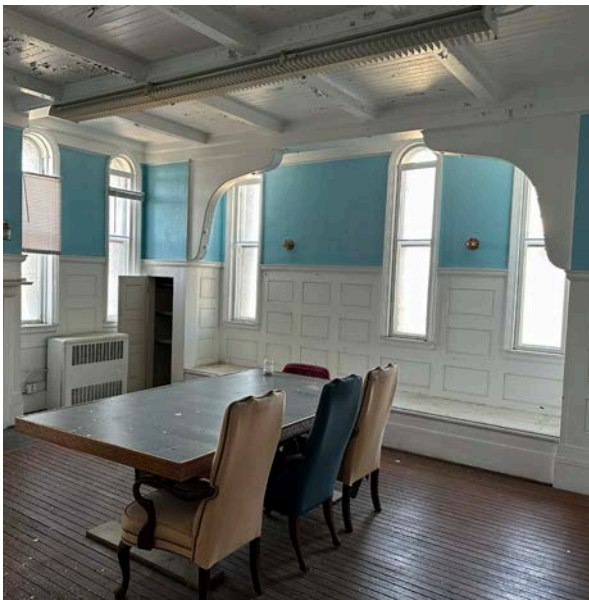
Figure 67 - Third Floor (Southwest)

**FIGURE 67 - THIRD FLOOR (SOUTHWEST)**

The southwest corner room appears to be in generally stable condition, particularly when evaluating the windows and hardwood flooring. The hardwood flooring throughout the space appears structurally sound and largely level, with no visible signs of buckling, warping, or significant displacement that would typically indicate prolonged moisture exposure. Minor surface wear, including scratches, debris, and localized finish deterioration, is present.

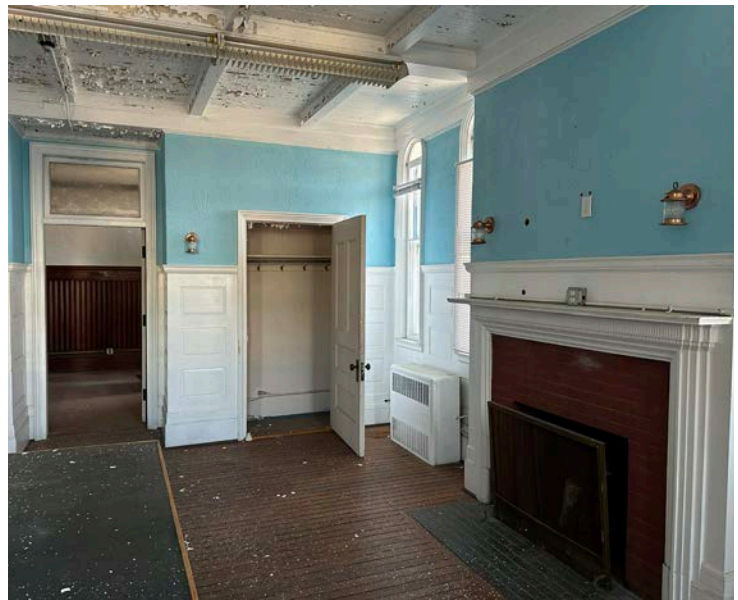
Figure 68 - Third Floor (Southwest)

**FIGURE 68 - THIRD FLOOR (SOUTHWEST)**

Deterioration is evident in adjacent finishes, particularly at the ceiling and upper wall surfaces. There is widespread peeling and flaking paint on the ceiling, especially along the beams, which may suggest past moisture exposure or prolonged humidity fluctuations.

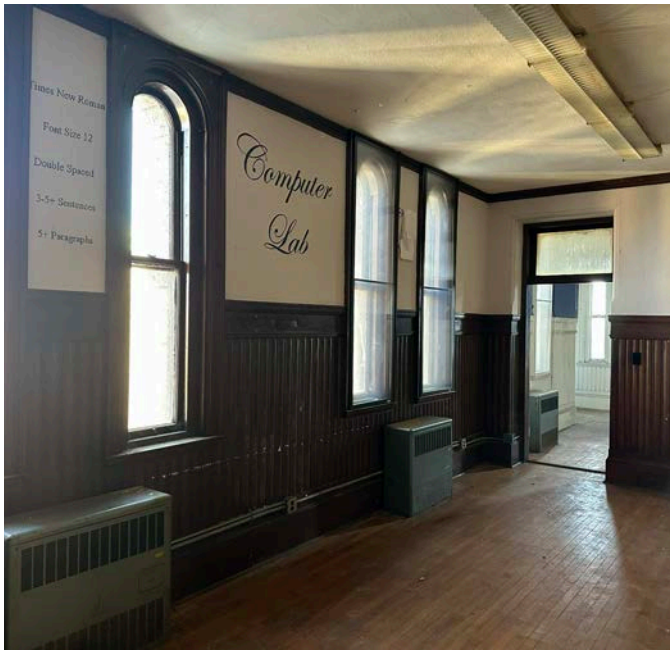
Figure 69 - Third Floor (West)

### FIGURE 69 - THIRD FLOOR (WEST)

Previous weatherproofing measures for the windows on the west side of the third floor appear to remain intact. The ceiling, wooden millwork, and hardwood floors were observed in stable condition.

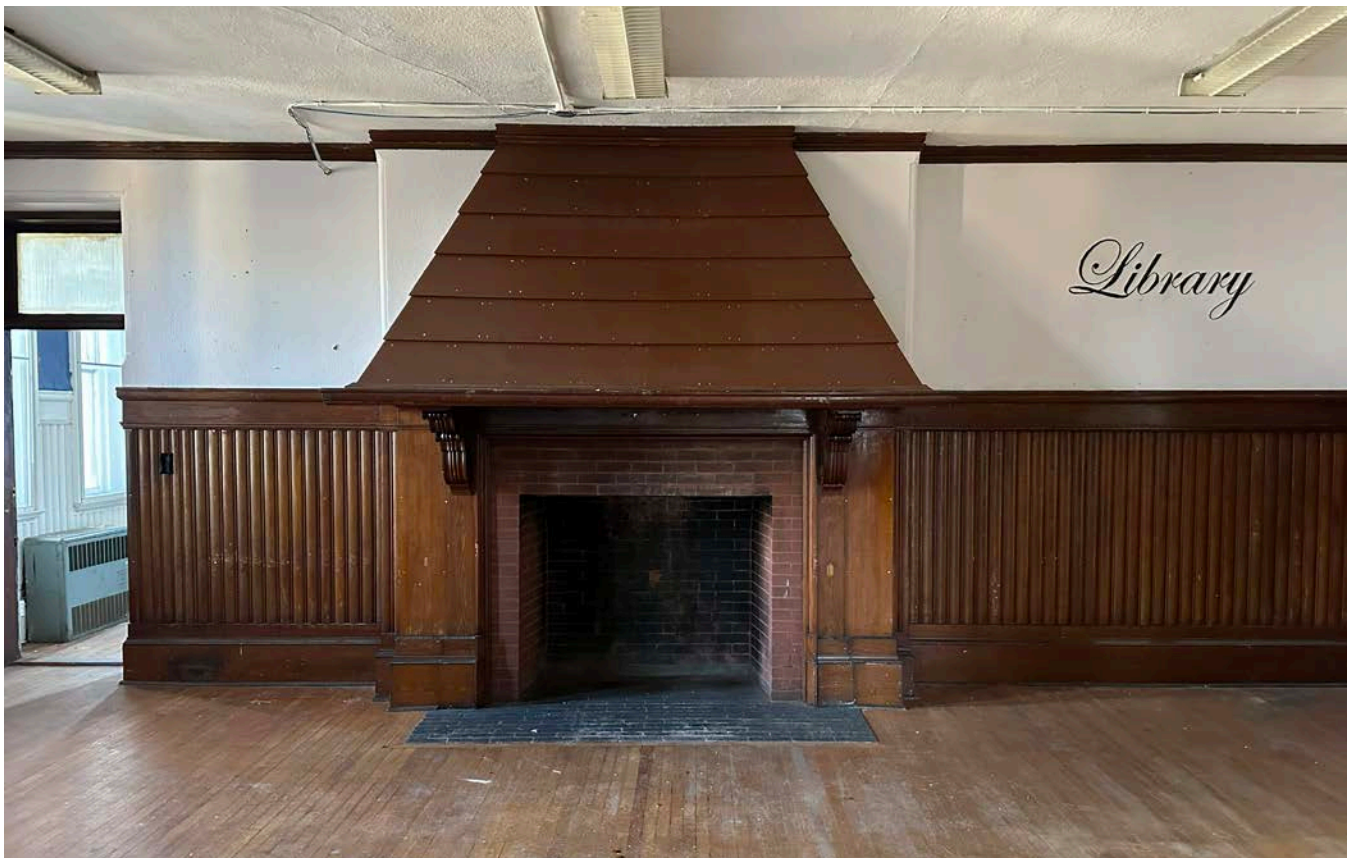
Figure 70 - Third Floor (West)

### FIGURE 70 - THIRD FLOOR (WEST)

The fireplace and surrounding wooden mantle appear to be in generally good and stable condition. The wood paneling, including the fluted wainscoting and mantle surround, remains intact with no visible signs of structural failure, warping, or significant material loss. The brick firebox and hearth also appear to be intact and the brickwork itself does not exhibit visible cracking, displacement, or mortar loss. Above the mantle, the hood enclosure is intact and appears securely fastened, though its surface shows minor cosmetic imperfections such as small fastener marks and slight irregularities in the finish.

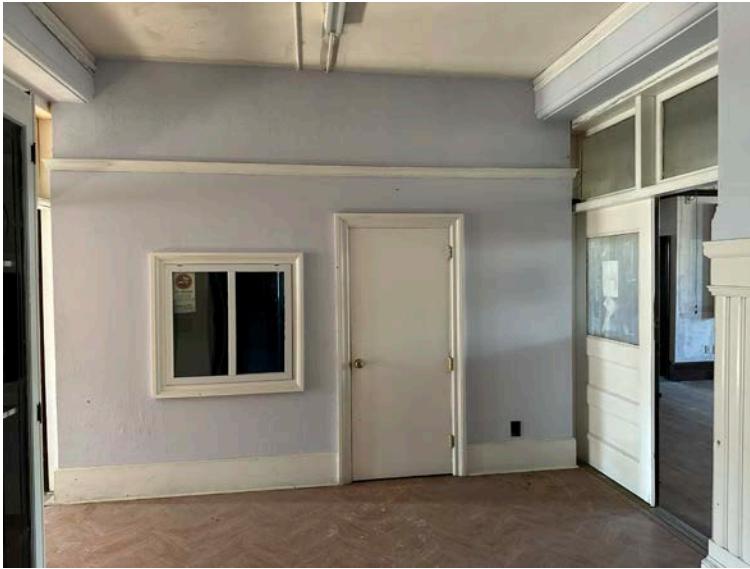
Figure 71 - Third Floor (Main Hallway)

**FIGURE 71 - THIRD FLOOR (MAIN HALLWAY)**

The hallway in front of the landing of the stairwell to the third floor appeared in stable condition with no signs of recent water infiltration.

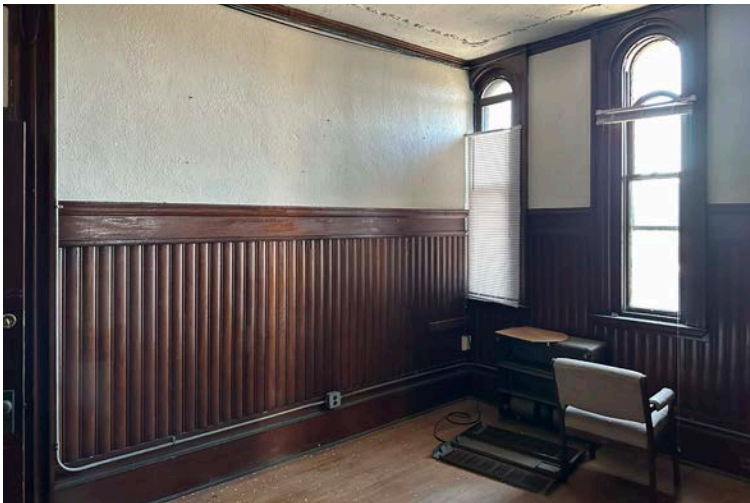
Figure 72 - Third Floor (South)

**FIGURE 72 - THIRD FLOOR (SOUTH)**

The surrounding wood trim, wall paneling, and window casings appear generally intact and in fair condition, with no immediate signs of active deformation or staining at lower elevations.

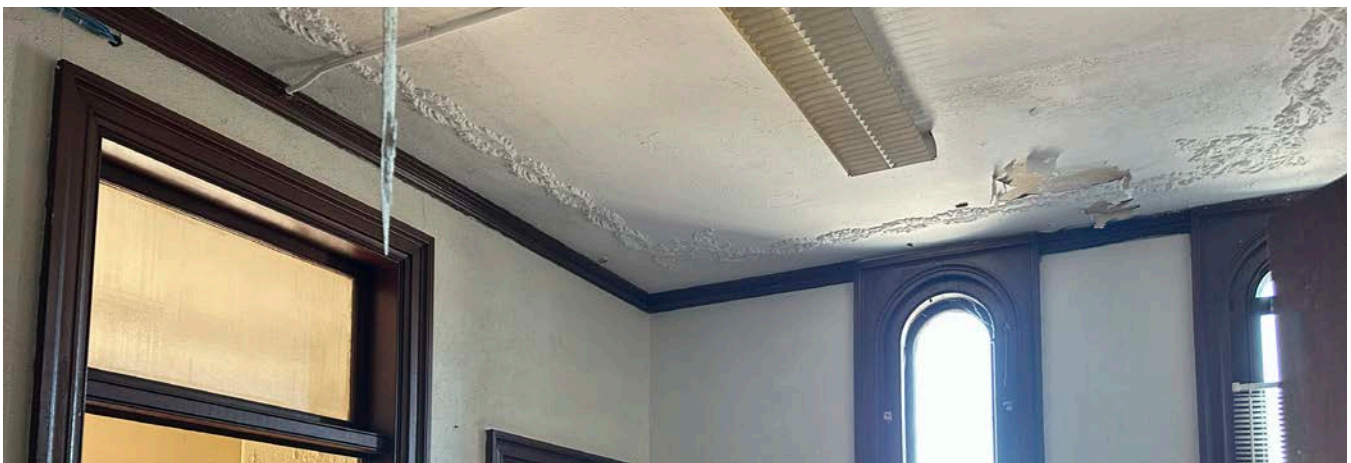
Figure 73 - Third Floor (South)

**FIGURE 73 - THIRD FLOOR (SOUTH)**

Signs of moisture were seen at the ceiling where paint was observed peeling, flaking, and falling along decorative finishes. These conditions are most pronounced along the decorative plaster molding with ornate detailing. The pattern and concentration of damage suggest prolonged or repeated exposure to moisture infiltration rather than a singular isolated event. The deterioration appears to be most severe near the corner above the arched window, where plaster failure is more advanced and underlying substrate may be exposed.

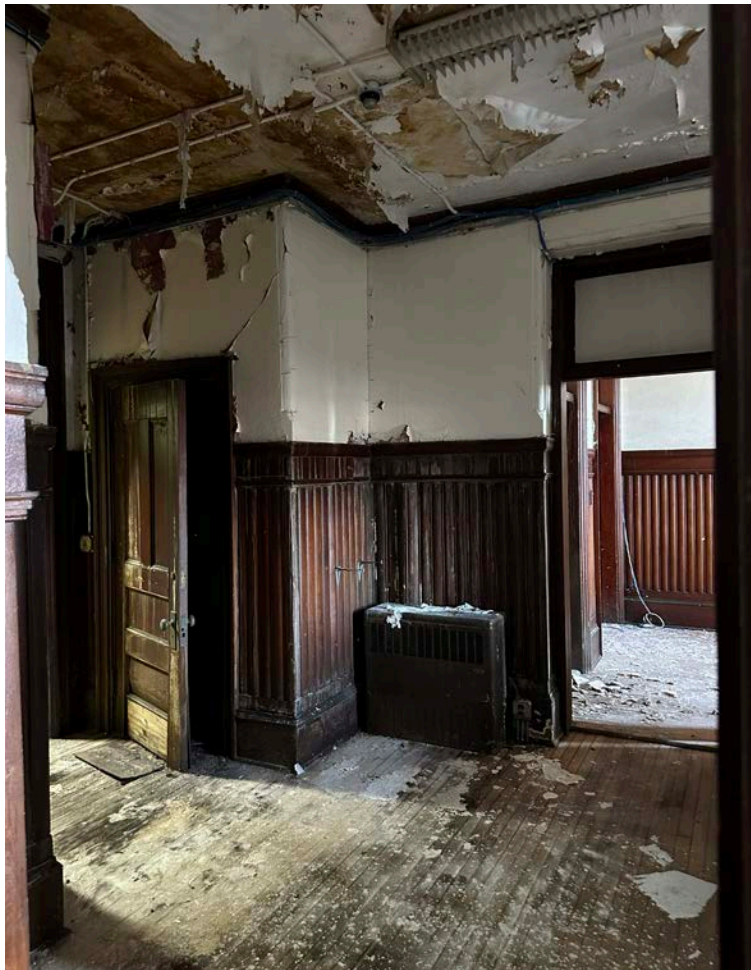
Figure 74 - Third Floor (South)

**FIGURE 74 - THIRD FLOOR (SOUTH)**

This area was part of the previous water intrusion event. There are no clear signs of active or recent water infiltration, such as fresh staining, visible dampness, or ongoing leakage. The ceiling shows extensive deterioration, with widespread peeling and delamination of paint layers. The pattern and extent of this peeling suggest that while active water entry may have ceased, the materials likely retain residual moisture or were not fully remediated following the initial incident. The walls exhibit cracking and localized surface deterioration, with minor separations visible at joints and transitions.

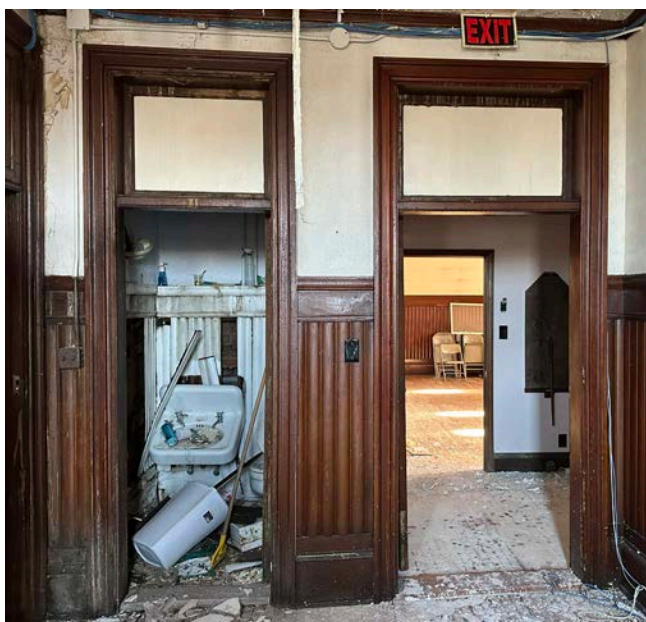
Figure 75 - Third Floor (Southeast)

**FIGURE 75 - THIRD FLOOR (SOUTHEAST)**

The flooring shows scattered debris from fallen ceiling material, but no obvious signs of active moisture-related deformation such as cupping or buckling are evident in this view.

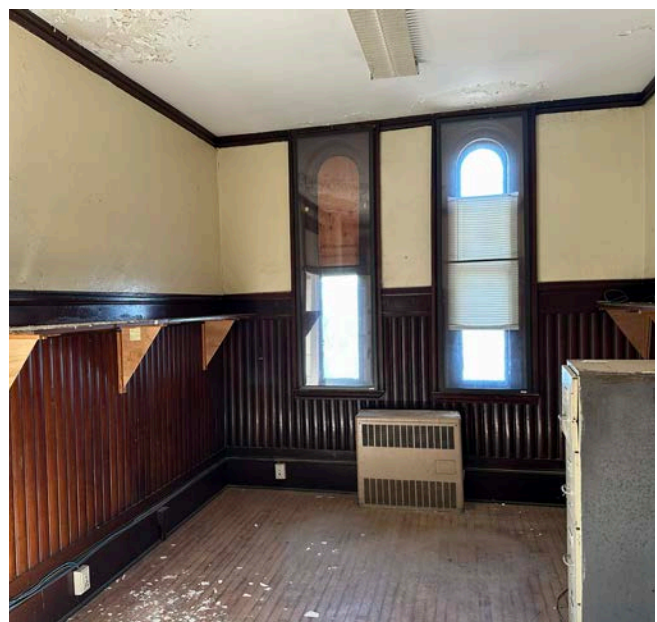
Figure 76 - Third Floor (Southeast)

**FIGURE 76 - THIRD FLOOR (SOUTHEAST)**

The wood wainscoting and trim appear largely intact and stable.

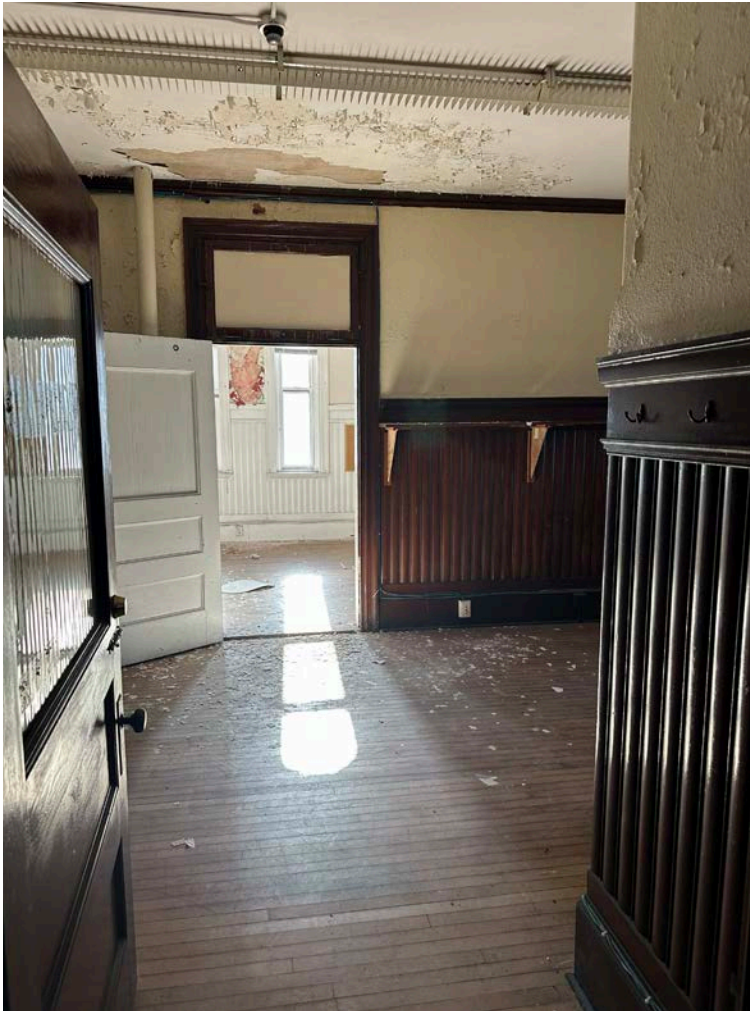
Figure 77 - Third Floor (East)

FIGURE 77 - THIRD FLOOR (EAST)

Signs of moisture were seen at the ceiling and paint was observed peeling, flaking, and falling along the ceiling.

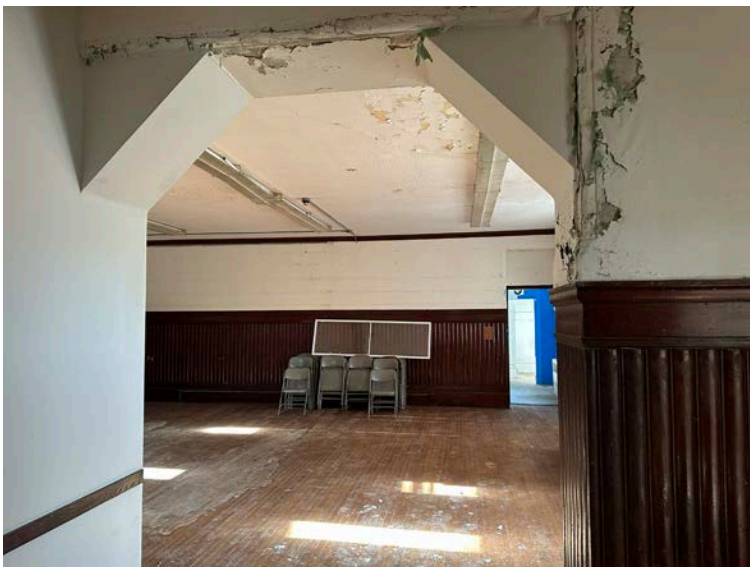
Figure 78 - Third Floor (East)

FIGURE 78 - THIRD FLOOR (EAST)

Signs of moisture were seen at the ceiling and paint was observed peeling and falling to the floor.

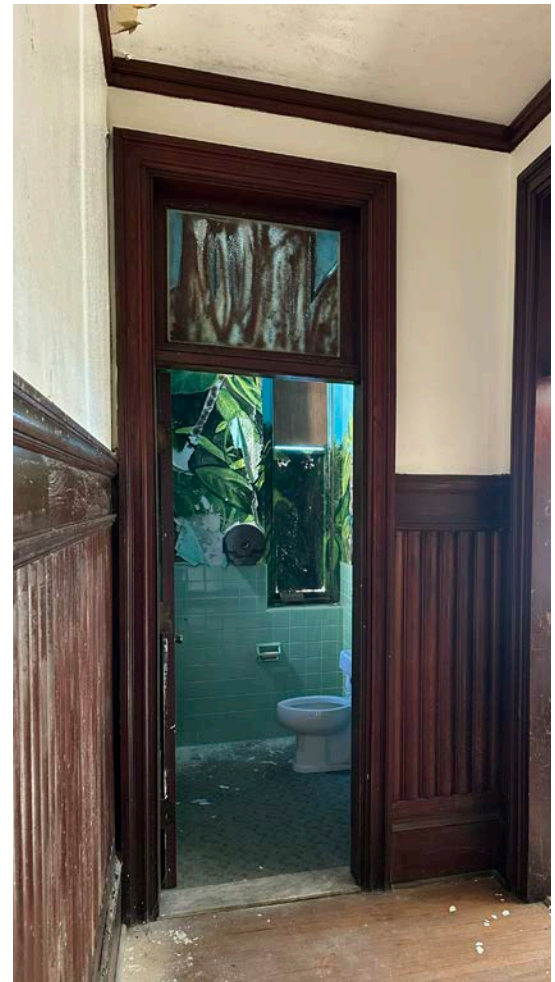
Figure 79 - Third Floor (East)

FIGURE 79 - THIRD FLOOR (EAST)

Signs of moisture were seen at the ceiling and the outer wall in the bathroom with paint observed peeling, flaking, and falling along the ceiling and wall joints.

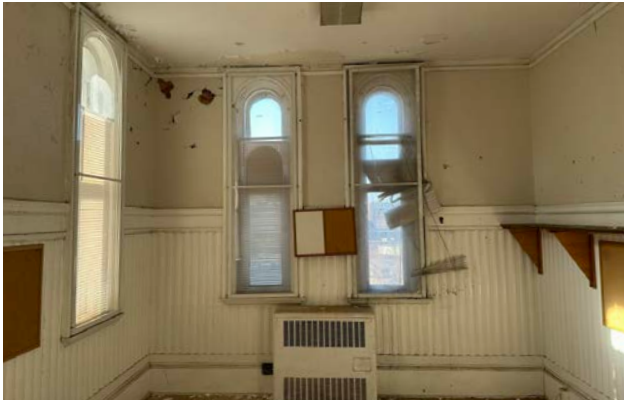
Figure 80 - Third Floor (Southeast)

### FIGURE 80 - THIRD FLOOR (SOUTHEAST)

The room exhibits clear signs of moisture-related deterioration, most notably at the ceiling and along the exterior wall. The deterioration appears most pronounced near the perimeter of the room, particularly along the wall-ceiling junction above the windows, suggesting prolonged exposure to moisture infiltration.

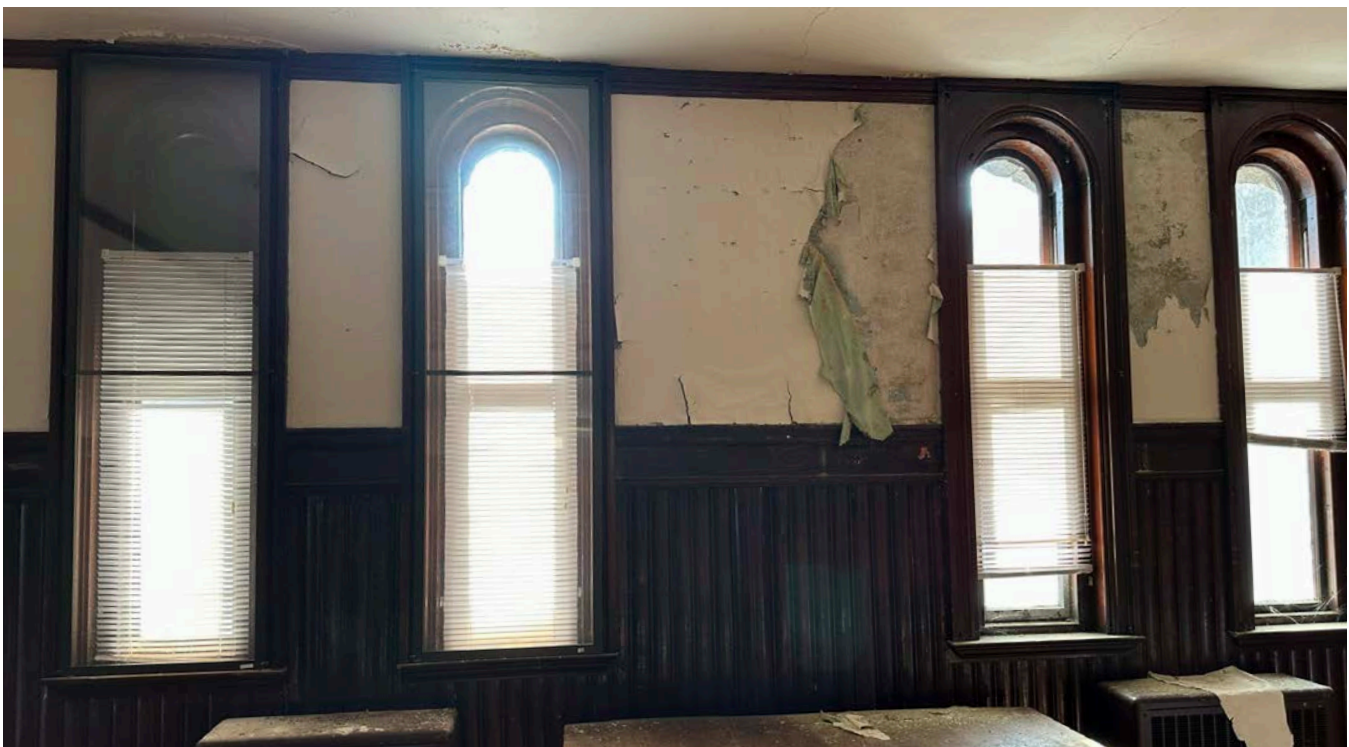
Figure 82 - Third Floor (East)

### FIGURE 82 - THIRD FLOOR (EAST)

Along the exterior wall, particularly around and between the arched window openings, there is visible cracking and localized material loss. The condition of the wall surface suggests repeated wetting and drying cycles, which may have contributed to the cracking and delamination observed.

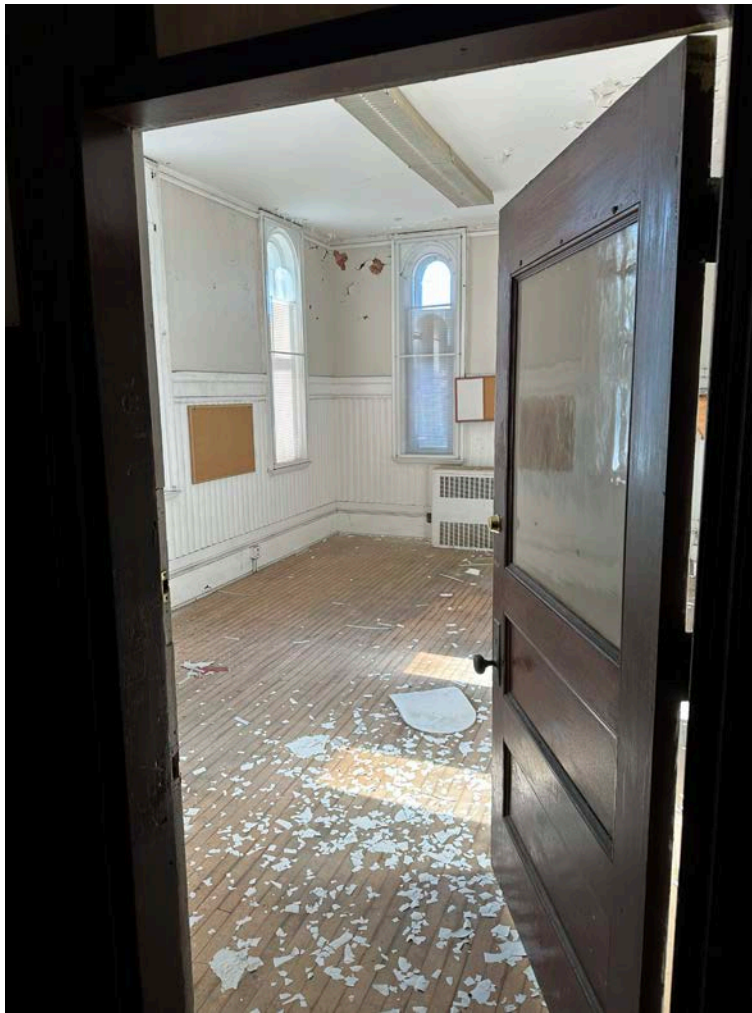
Figure 83 - Third Floor (Southeast)

FIGURE 83 - THIRD FLOOR (SOUTHEAST)

Signs of moisture exposure were seen at the ceiling and the outer wall with paint observed peeling and flaking as well as larger pieces falling to the floor.

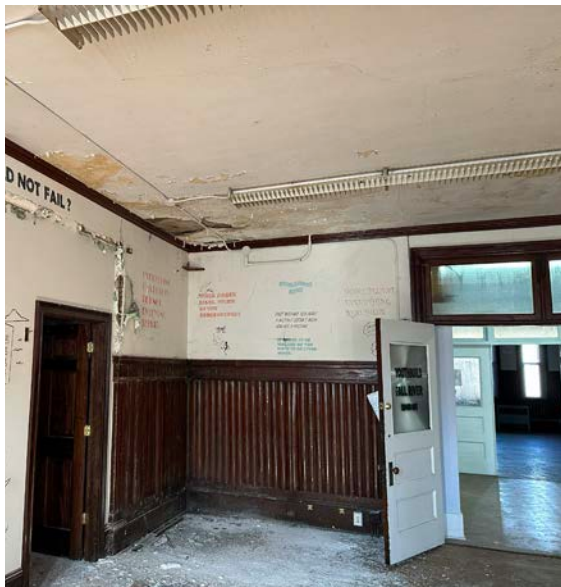
Figure 84 - Third Floor (East)

FIGURE 84 - THIRD FLOOR (EAST)

Signs of moisture were seen at the ceiling and the interior walls with paint observed peeling and some plaster from the ceiling falling.

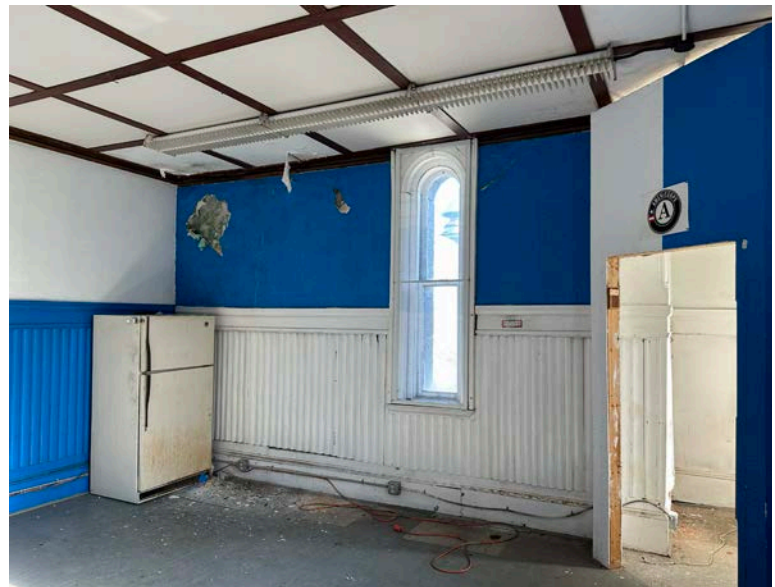
Figure 85 - Third Floor (East)

FIGURE 85 - THIRD FLOOR (EAST)

Signs of moisture were seen at the ceiling and the outer wall with paint observed peeling and some plaster from the ceiling falling.

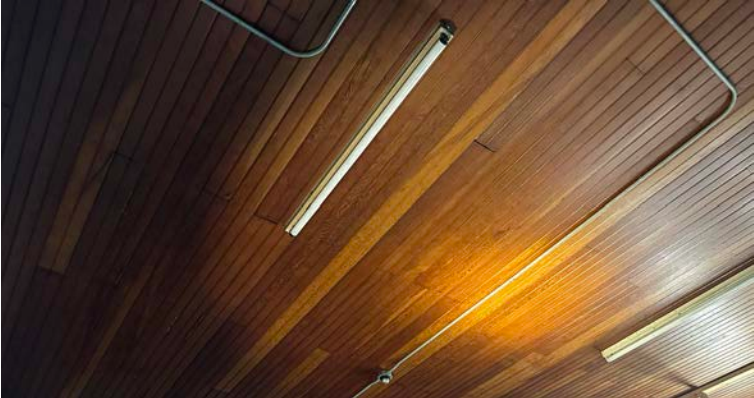
Figure 88 - Fourth Floor (Southwest Ceiling)

**FIGURE 88 - FOURTH FLOOR (SOUTHWEST CEILING)**  
The wooden ceiling in the southwest corner of the fourth floor appeared in good condition and did not show any signs of buckling.

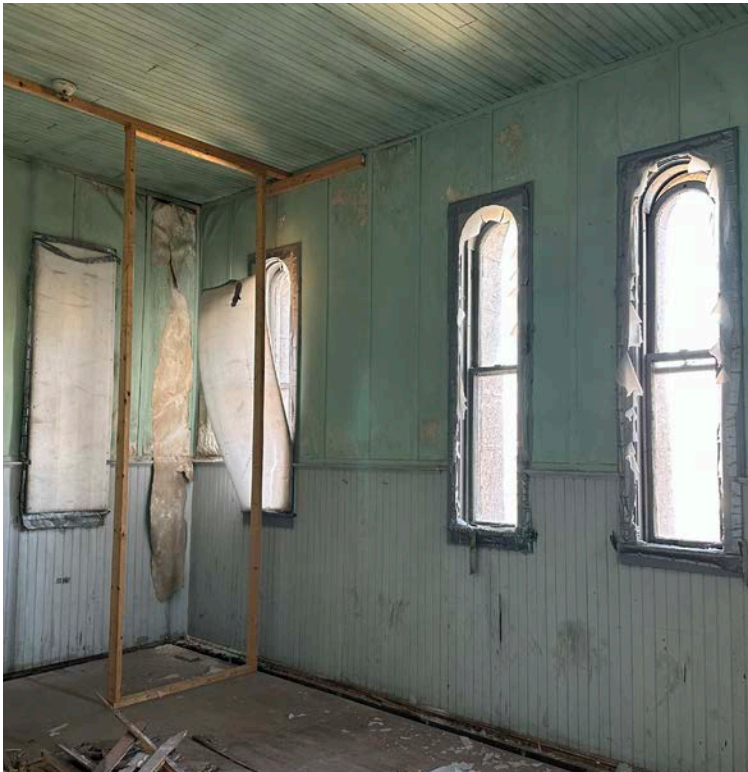
Figure 90 - Fourth Floor (Southwest)

### FIGURE 90 - FOURTH FLOOR (SOUTHWEST)

Multiple window openings show deteriorated or missing perimeter sealing, with visible gaps and compromised coverings allowing direct pathways for air and water penetration. The painted finishes on the upper wall panels are blistering and peeling, with localized areas of staining and discoloration indicative of prolonged exposure to moisture. In some locations, sections of the interior wall finish have detached entirely, exposing underlying substrates. The lower beadboard wainscoting also shows signs of water-related distress, including staining, surface wear, and potential early-stage deterioration at the base where moisture may be accumulating. The condition of the window assemblies and surrounding materials suggests that water infiltration may be ongoing, particularly during precipitation events or freeze-thaw cycles.

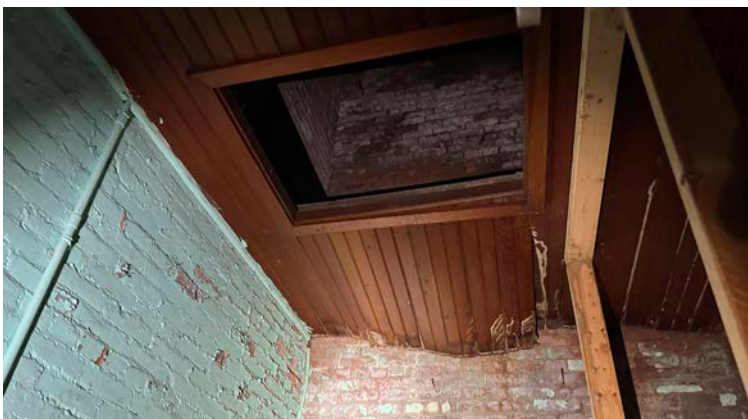
Figure 92 - Fourth Floor (South)

### FIGURE 92 - FOURTH FLOOR (SOUTH)

Notable signs of moisture exposure are visible along the interface between the wood ceiling and the brick wall of the attic access opening. There is a clear separation where a portion of the ceiling has pulled away or broken from the brick wall, leaving a visible gap. This detachment suggests deterioration of fastening points or substrate materials. The brick masonry shows signs of wear, including flaking paint, efflorescence-like discoloration, and minor mortar deterioration.

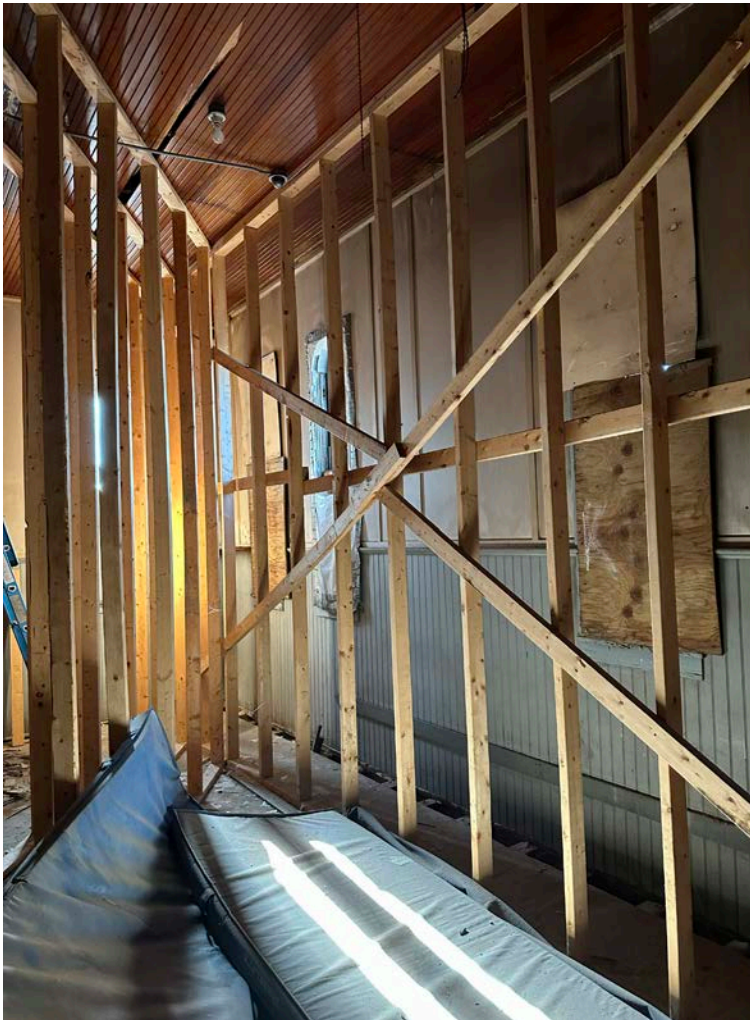
Figure 93 - Fourth Floor (Southeast)

## FIGURE 93 - FOURTH FLOOR (SOUTHEAST)

New vertical wood studs have been installed along the length of the wall as part of a reinforcement effort to ensure the ceiling is stabilized. The upper portion of the space features a sloped wood plank ceiling that appears largely intact but shows localized signs of distress. There is a visible opening or separation in the ceiling boards near a light fixture, which may indicate prior moisture intrusion, structural movement, or localized failure.

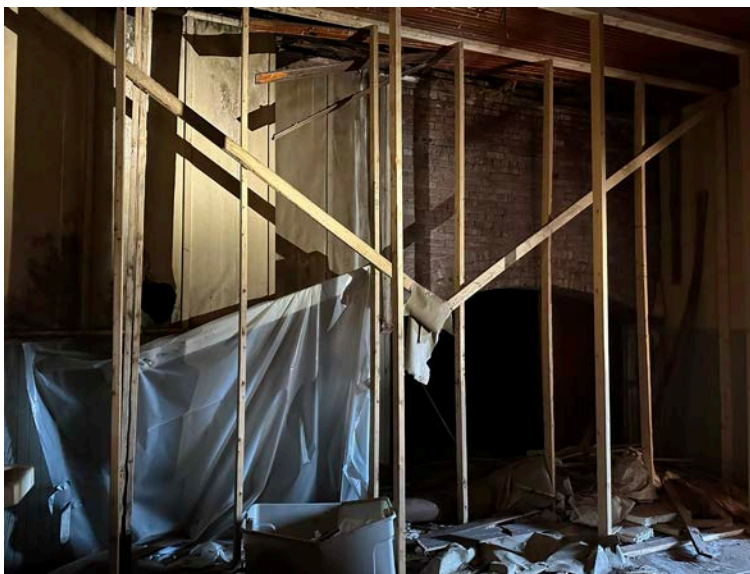
Figure 94 - Fourth Floor (South)

## FIGURE 94 - FOURTH FLOOR (SOUTH)

Additional bracing with wood plank pieces separated from the ceiling above.
