# BANK STREET ARMORY

## PRELIMINARY EXISTING CONDITIONS REPORT

72 Bank Street  
Fall River, MA

Prepared by the Preservation Society of Fall River, Inc.

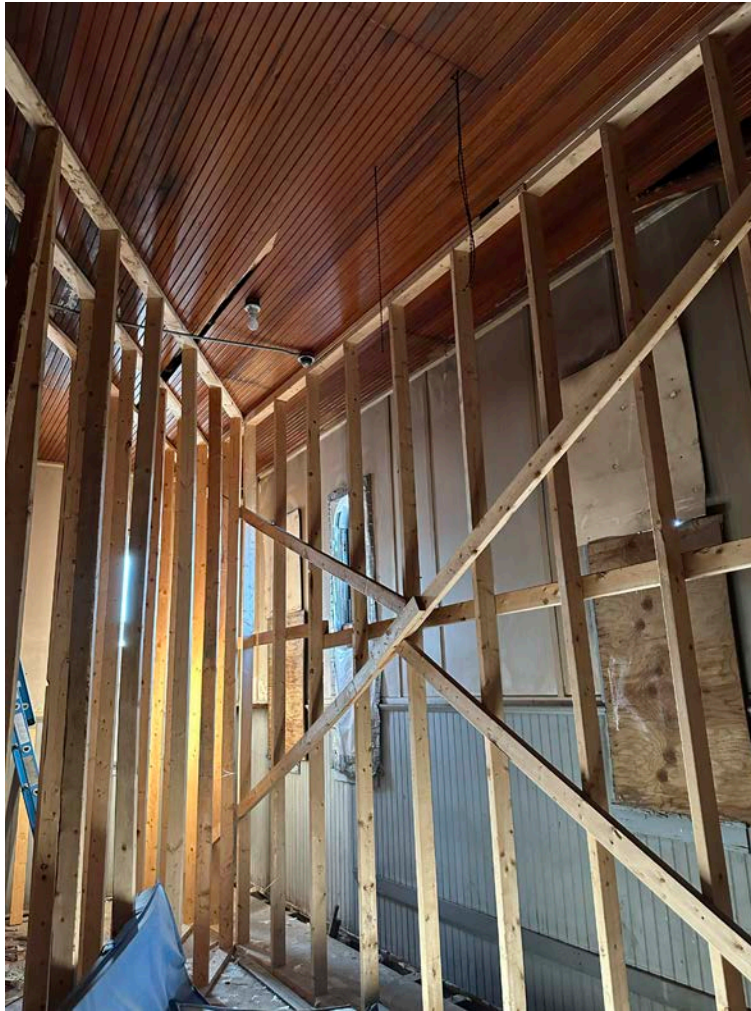
Figure 96 - Fourth Floor (Southeast)

### FIGURE 96 - FOURTH FLOOR (SOUTHEAST)

Along the exterior wall, several window openings are visible, many of which are covered or boarded from the interior. The wall surface beneath the windows shows a combination of older finishes, including beadboard paneling and plaster, with areas of patching and deterioration. Some sections exhibit staining and discoloration, which may be indicative of past moisture infiltration. The window framing and surrounding materials appear uneven and inconsistently sealed.

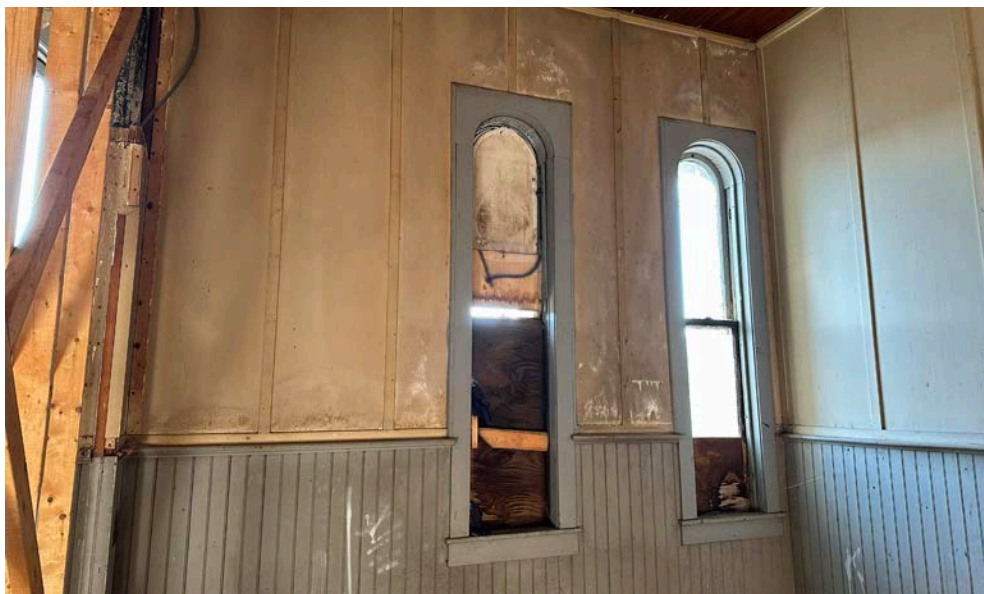
Figure 97 - Fourth Floor (Southeast)

### FIGURE 97 - FOURTH FLOOR (SOUTHEAST)

Signs of moisture intrusion at the windows, which are improperly weatherproofed. Observations include discoloration around the wall and window sills as well as bubbling of the paint.

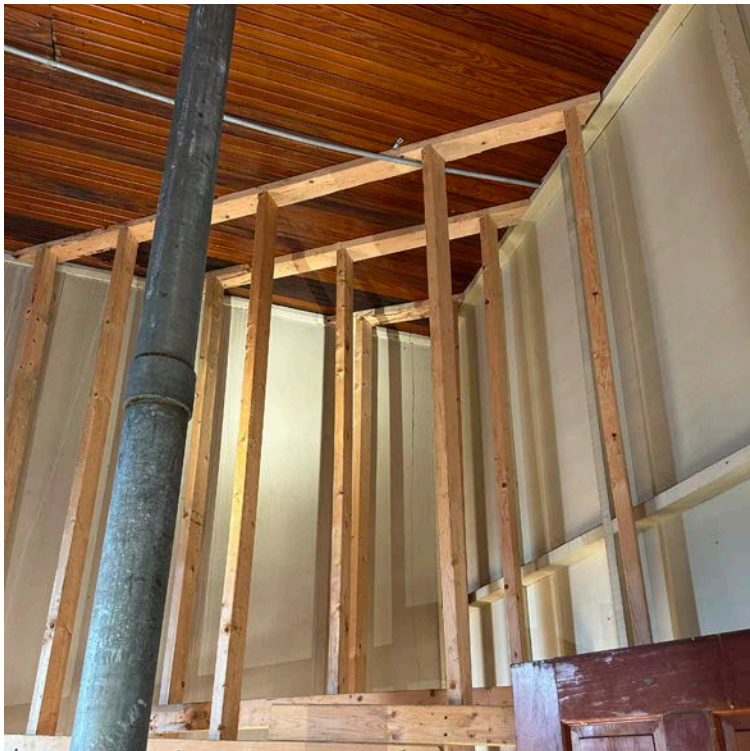
Figure 98 - Fourth Floor (East)

**FIGURE 98 - FOURTH FLOOR (EAST)**

Diagonal bracing members are present, indicating temporary structural support to stabilize the wood plank ceiling. These stabilization measures appear to have succeeded in preventing the ceiling from buckling in this location.

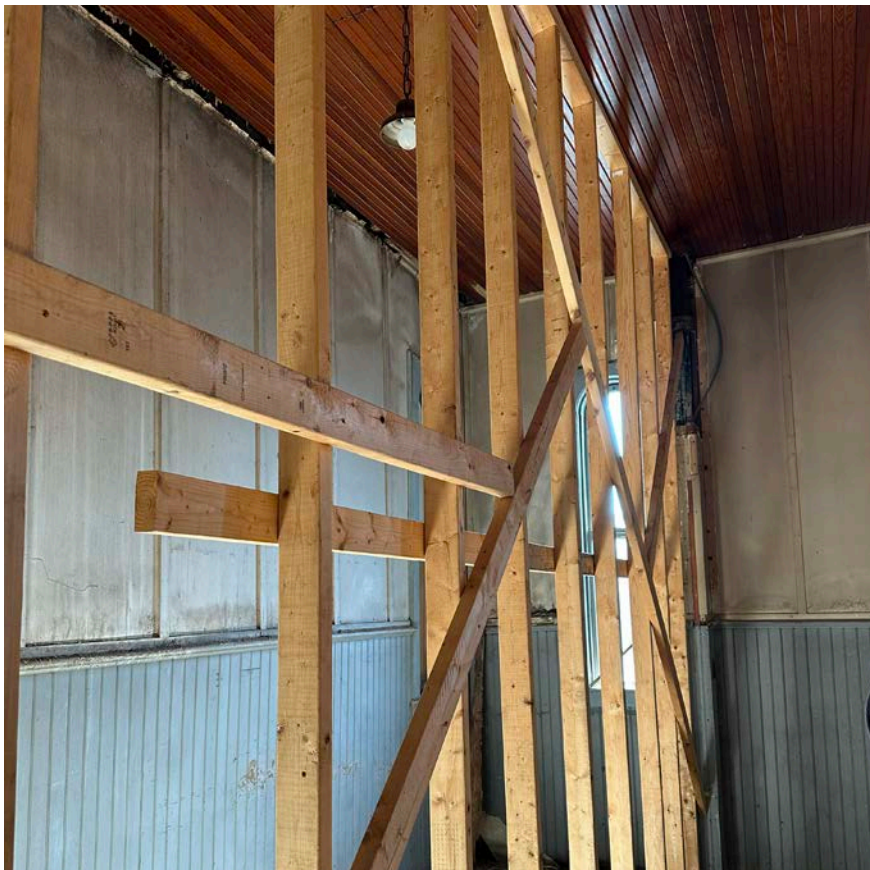
Figure 99 - Fourth Floor (East)

**FIGURE 99 - FOURTH FLOOR (EAST)**

Additional bracing for the wood plank ceiling with signs of moisture infiltration and deterioration, especially located at the junction where the wall meets the ceiling. Evidence of prior damage — potentially related to water intrusion or prolonged exposure — remains visible in the ceiling and wall assemblies.

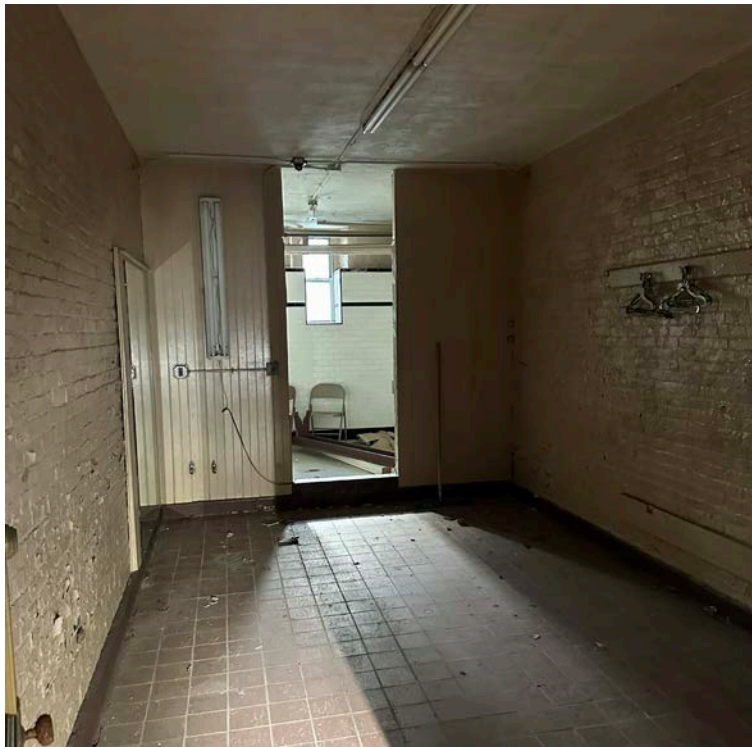
Figure 100 - Basement (West)

## FIGURE 100 - BASEMENT (WEST)

The locker room in the basement exhibits signs of moisture deterioration and elevated humidity with paint surfaces peeling and flaking on walls. The extent of corrosion, material loss, and peeling finishes in the basement strongly suggests chronic water exposure, and inadequate ventilation.

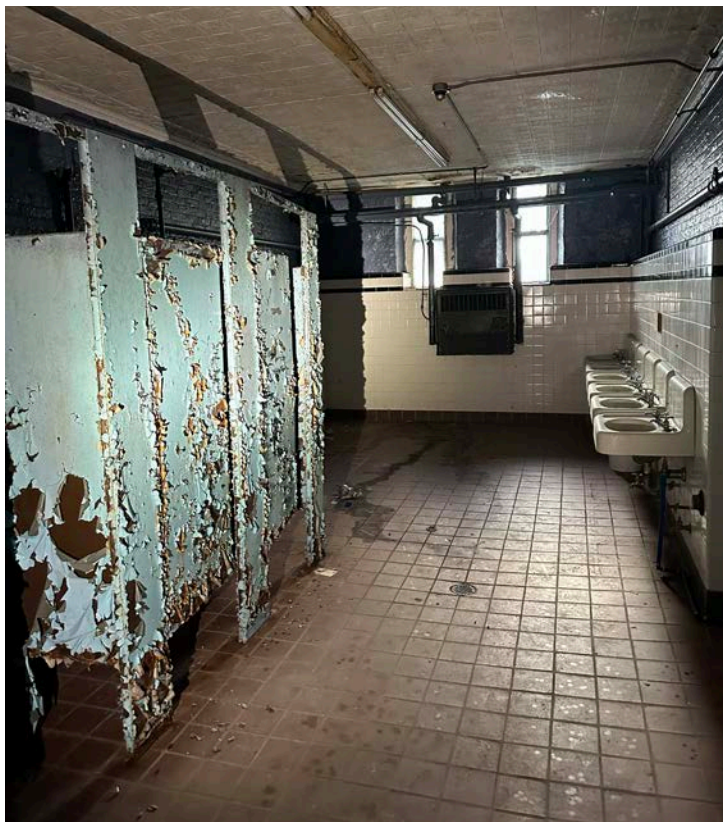
Figure 101 - Basement (Southwest)

## FIGURE 101 - BASEMENT (SOUTHWEST)

The rest room exhibits widespread signs of prolonged moisture exposure with the most severe deterioration is observed at the row of toilet partitions. These partitions appear to be constructed of painted metal or fiberboard and are extensively corroded and delaminated. The paint coating has failed almost entirely, with large sections of peeling, flaking, and loss of finish exposing heavily rusted substrate beneath. In several locations, the material has deteriorated to the point of perforation, with visible holes and missing sections at the lower portions of the panels. The damage is most pronounced at the base of the partitions, suggesting repeated wetting and inadequate drying over time. The tiled wall behind the sinks appears stable, though the grout lines may require closer inspection for deterioration. The ceiling features a patterned pressed-tin or similar decorative panel system, which appears mostly intact but shows staining and discoloration in several areas.

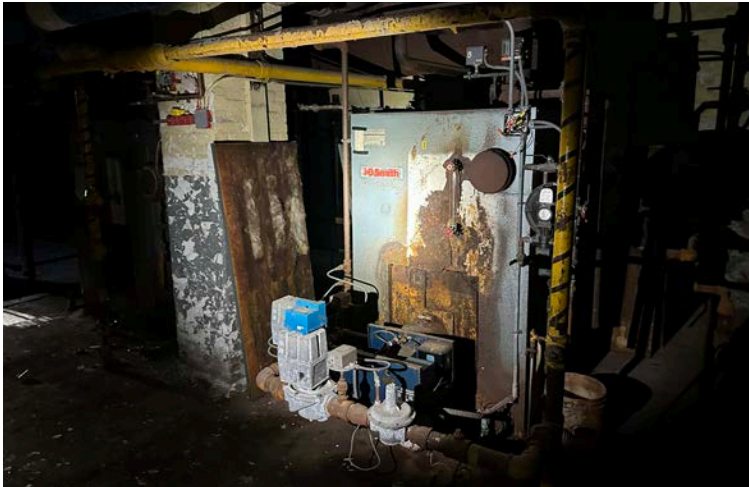
Figure 102 - Basement (West)

FIGURE 102 - BASEMENT (WEST)

The two large, older boiler units located within the basement mechanical room are inactive and in a significantly deteriorated condition following a prior water infiltration and flooding event. The equipment shows extensive surface corrosion, particularly along the lower sections of the housings, burner access panels, and piping connections—consistent with prolonged exposure to standing water and high humidity conditions.

- **Temporary Heating:** It is recommended that the City invest in a temporary heating system and ensure it is installed before the 2027 winter. This would help prevent further deterioration of the property from enhanced freeze-thaw cycles and reduce overall moisture inside the building.

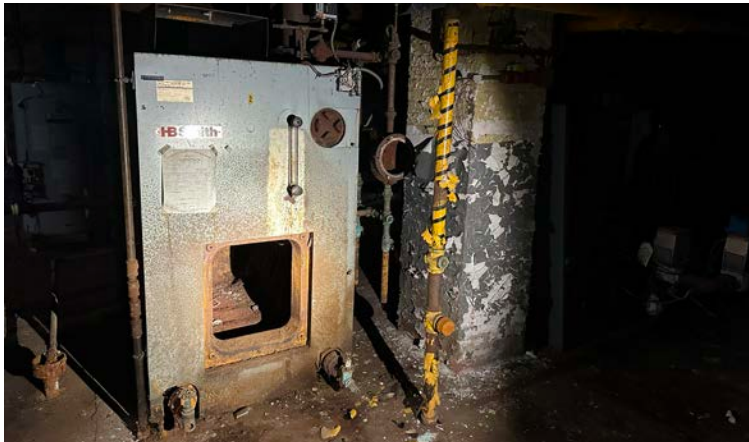
Figure 103 - Basement (West)

FIGURE 103 - BASEMENT (WEST)

The boiler casings exhibit widespread rusting, paint failure, and material degradation, with the most severe corrosion concentrated near the base where floodwaters likely accumulated. The presence of residue lines and staining on adjacent surfaces is also likely from past flooding.

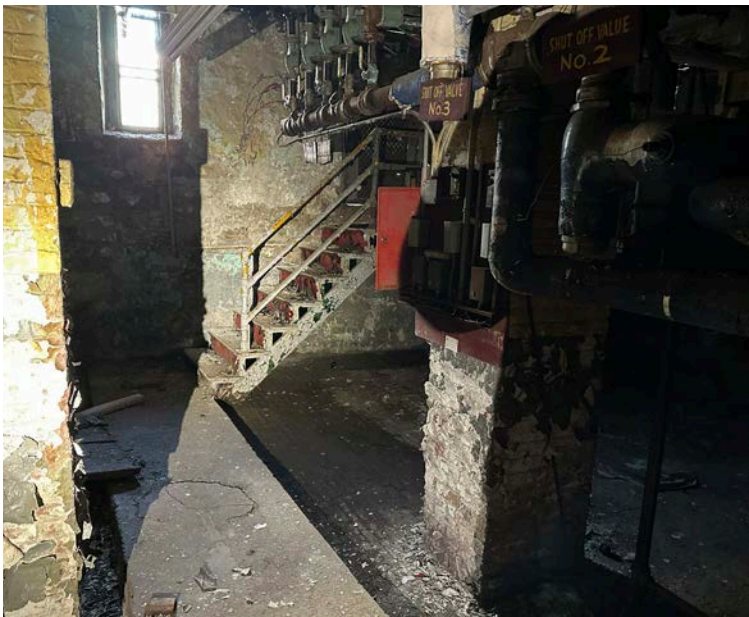
Figure 104 - Basement (West)

FIGURE 104 - BASEMENT (WEST)

The floor shows signs of residual moisture staining and debris accumulation, while nearby wall surfaces exhibit peeling paint and delamination, indicative of sustained damp conditions. Given that no active heating system has been operational since the flooding event, the space appears unconditioned, which likely contributes to ongoing freeze-thaw cycles and elevated humidity levels. These environmental factors are accelerating the deterioration of both mechanical equipment and the entire building.
